SUBJECT John Anglin, Clarence Anglin and  
Frank Lee Morris Escape from Alcatraz

FILE NUMBER 76-26295

VOLUME NUMBER Enclosures 76, 137, 155 and 179

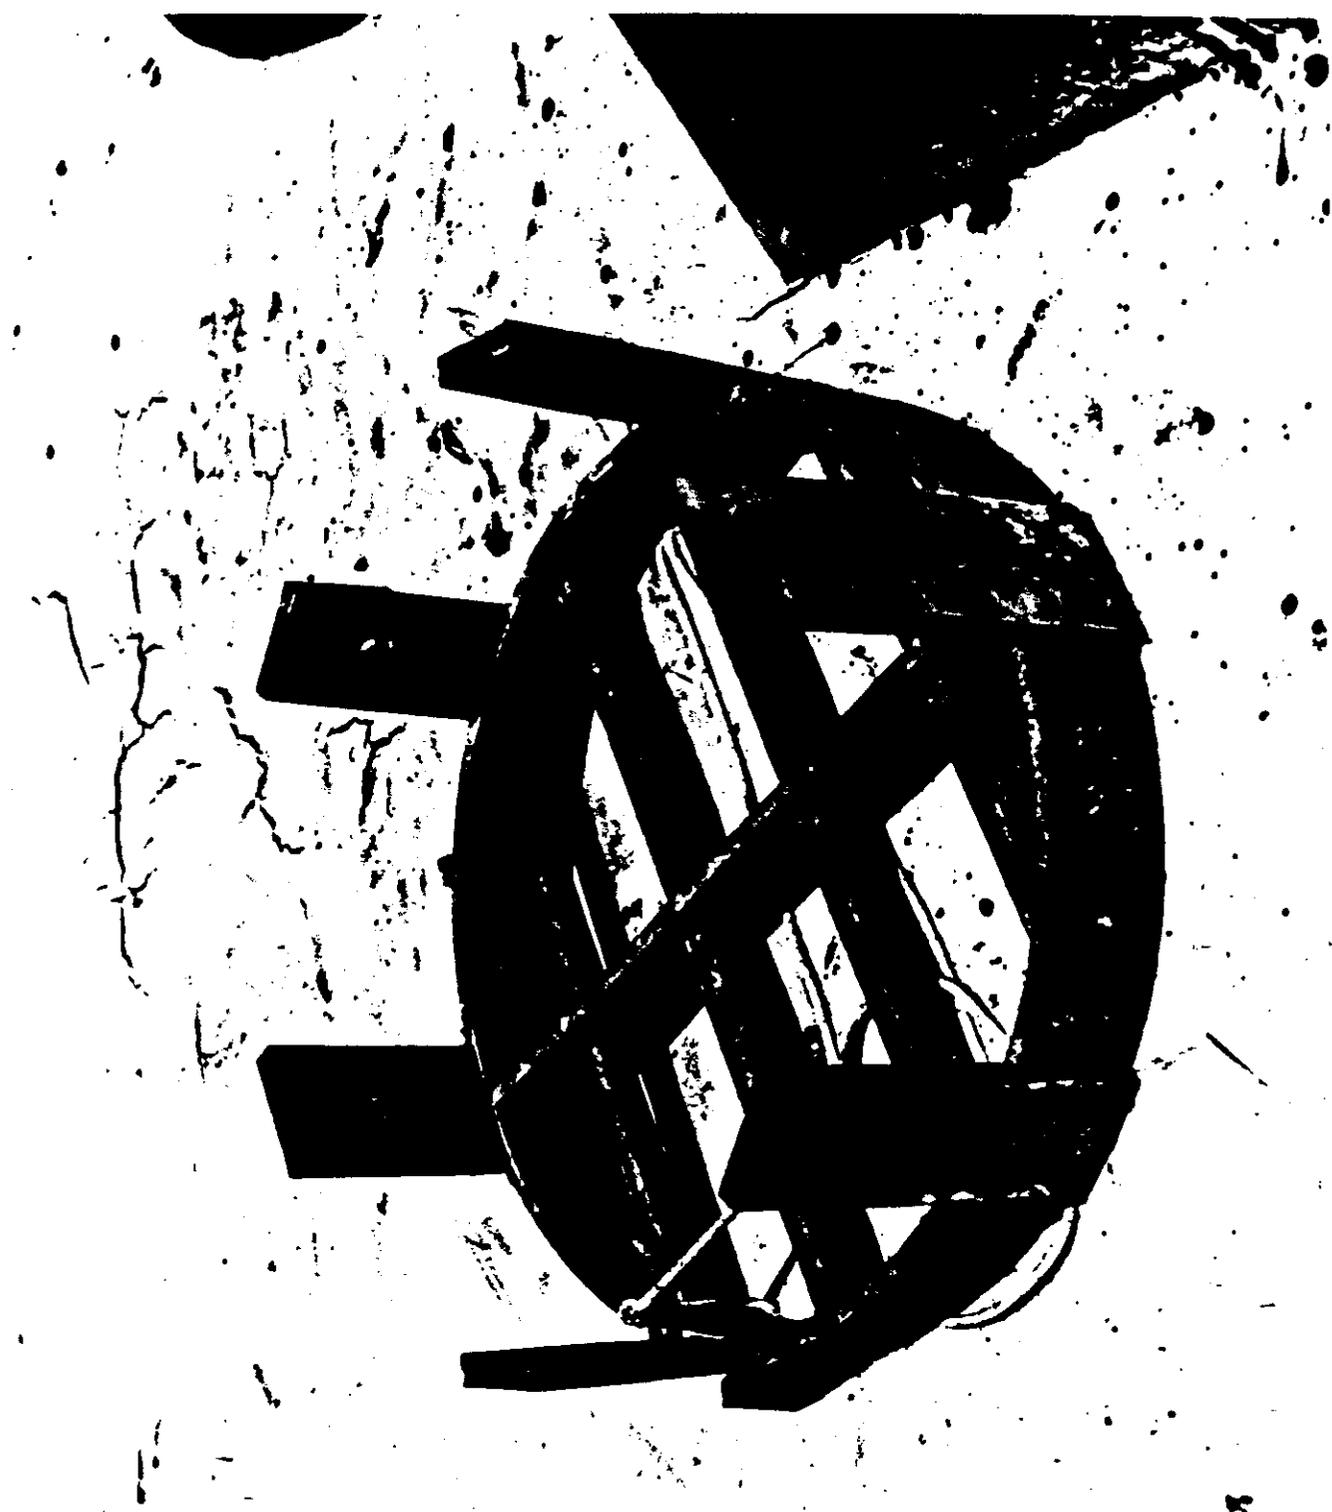
1-2 This is a more detailed photograph of the galvanized metal grate shown in 1-1.

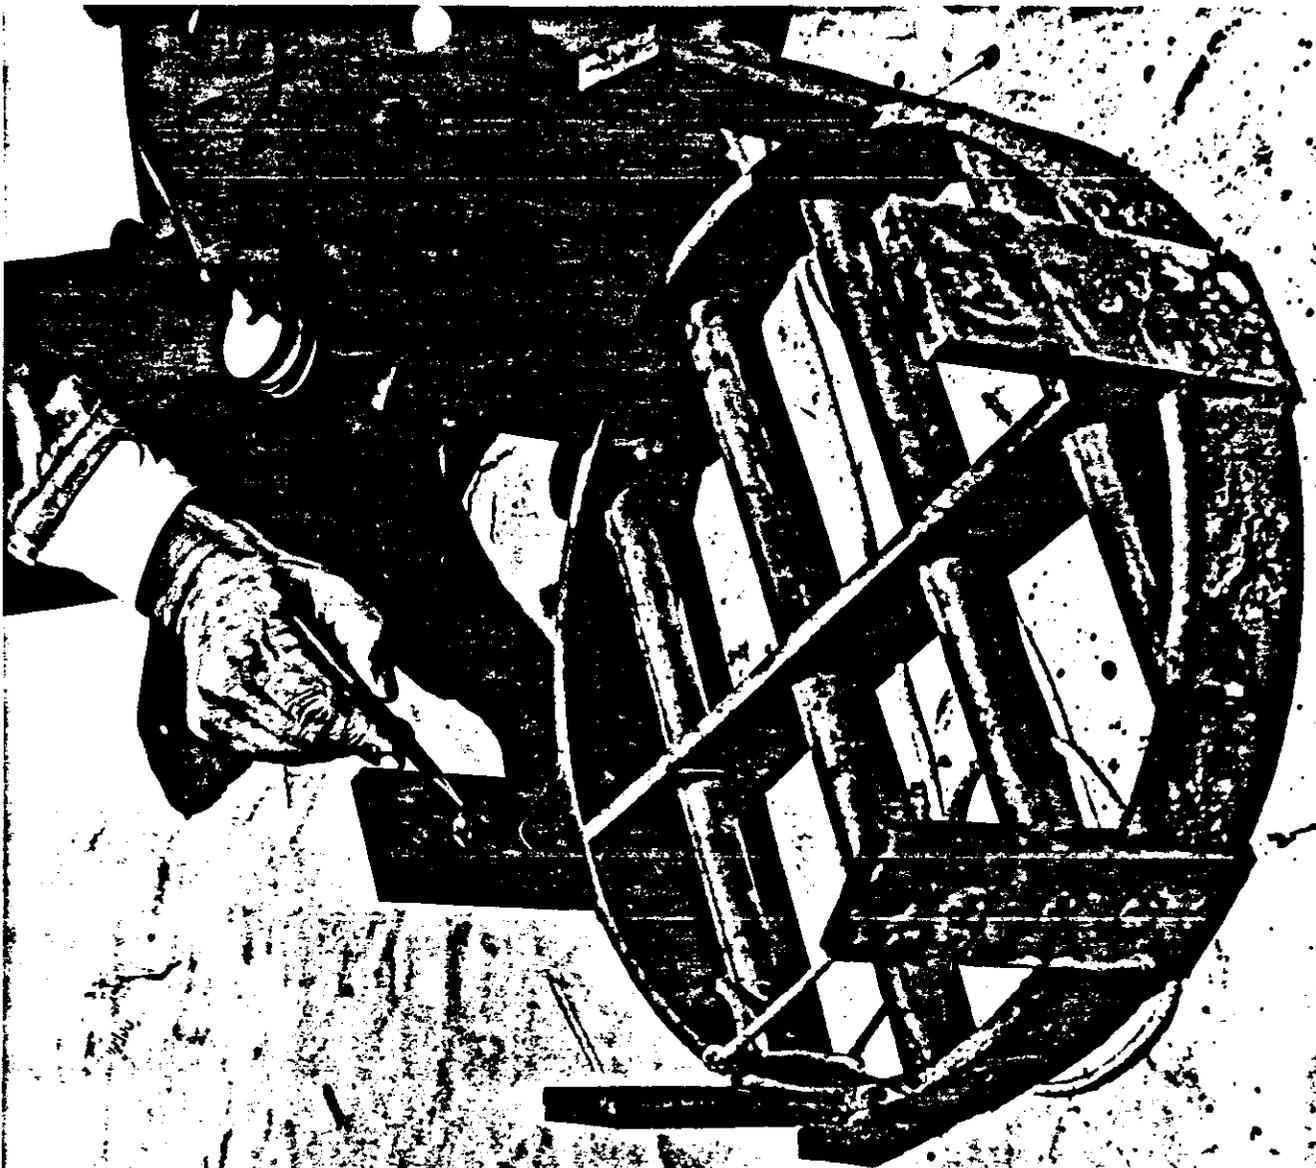
1-3 Same as 1-2 with the exception that pencil is used to point out the bolt head made of soap which is one of two found on the roof.

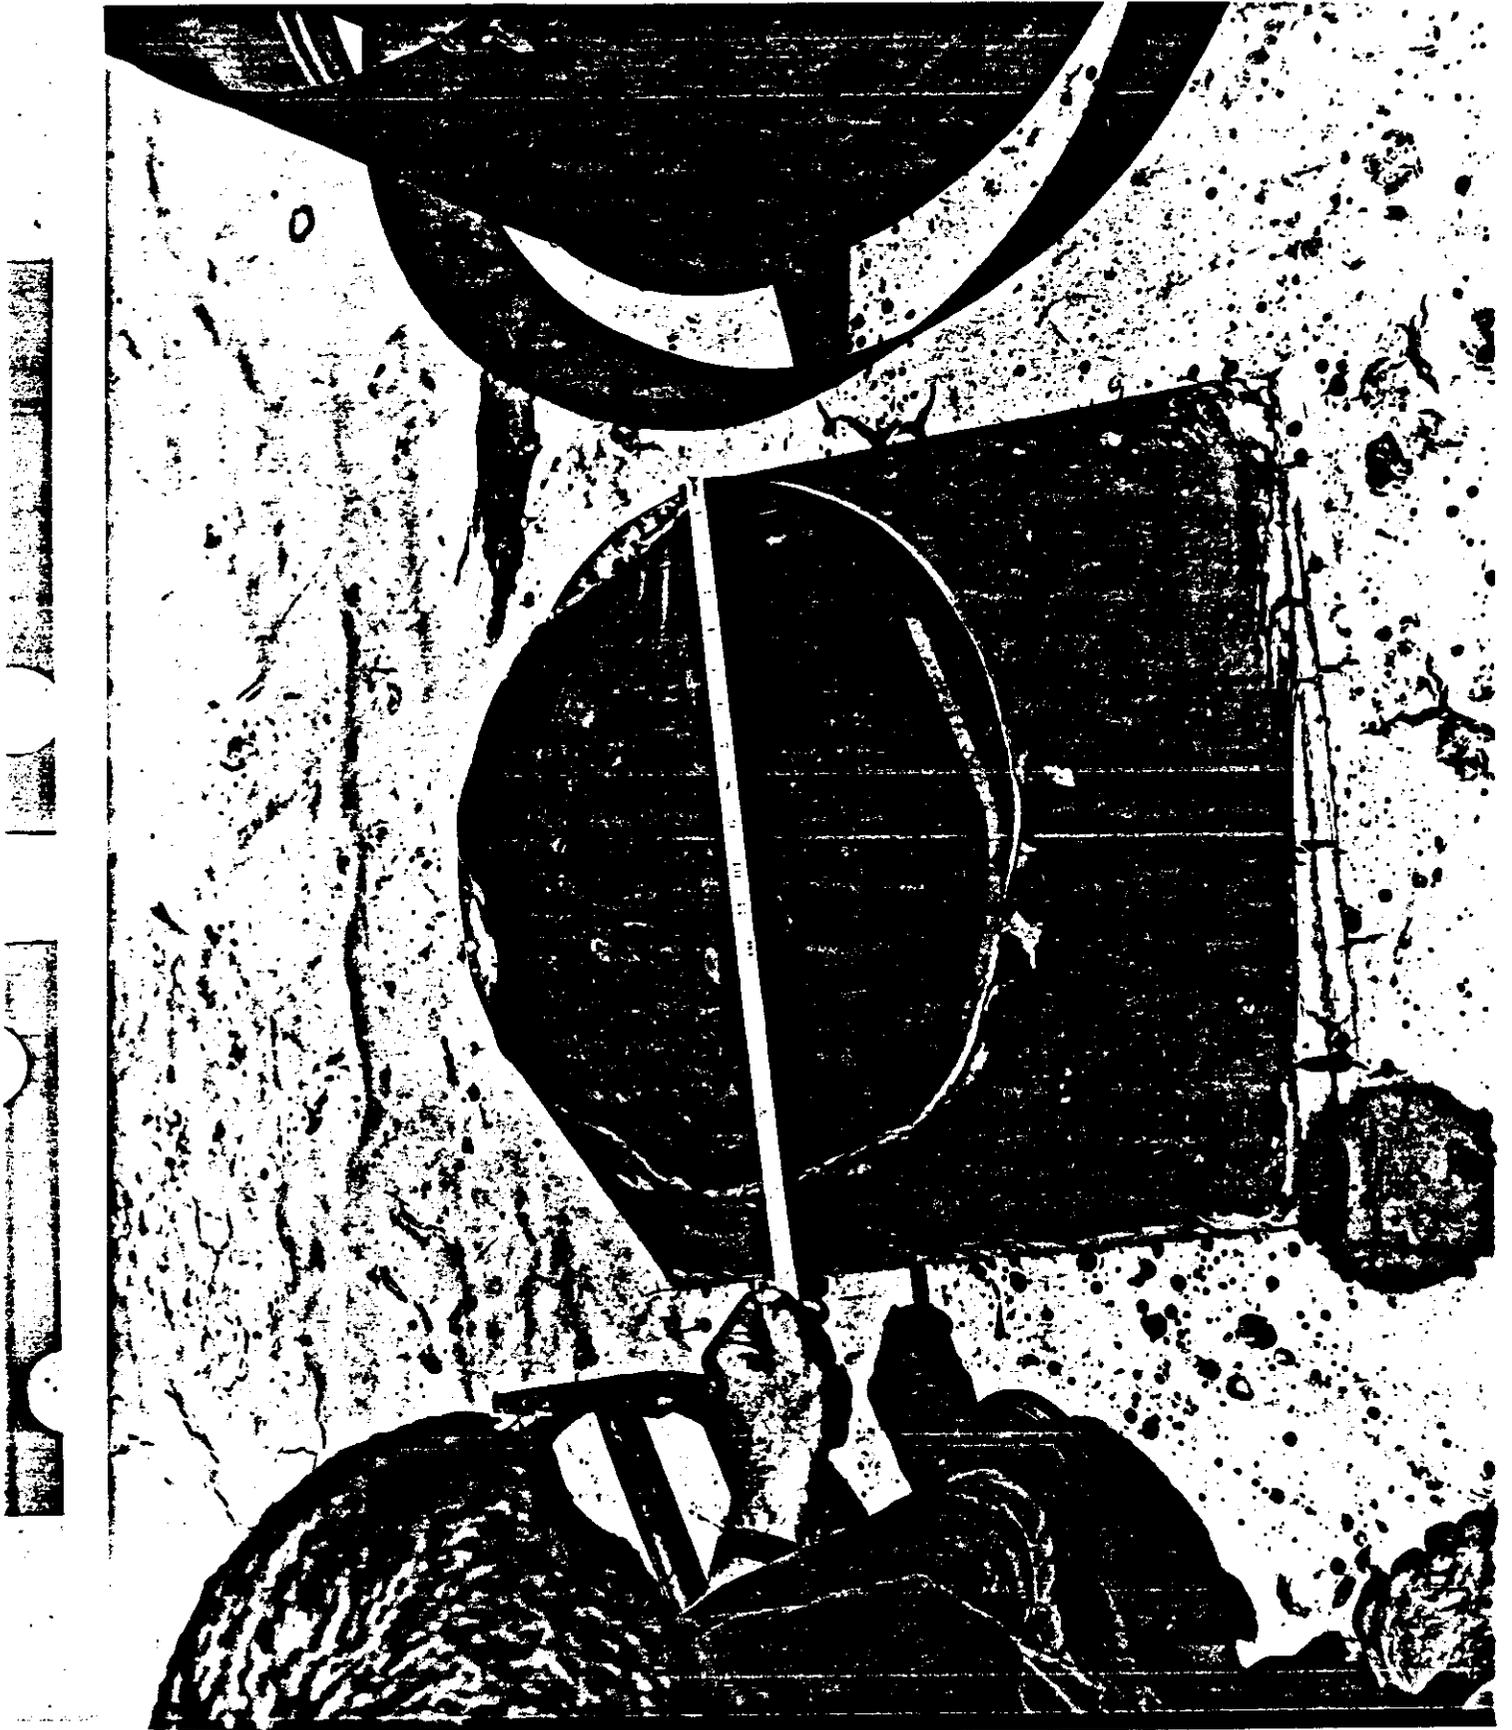
1-5 Photo same as 1-4 with the exception a tape is stretched across the opening showing the opening to be approximately eighteen inches in diameter.

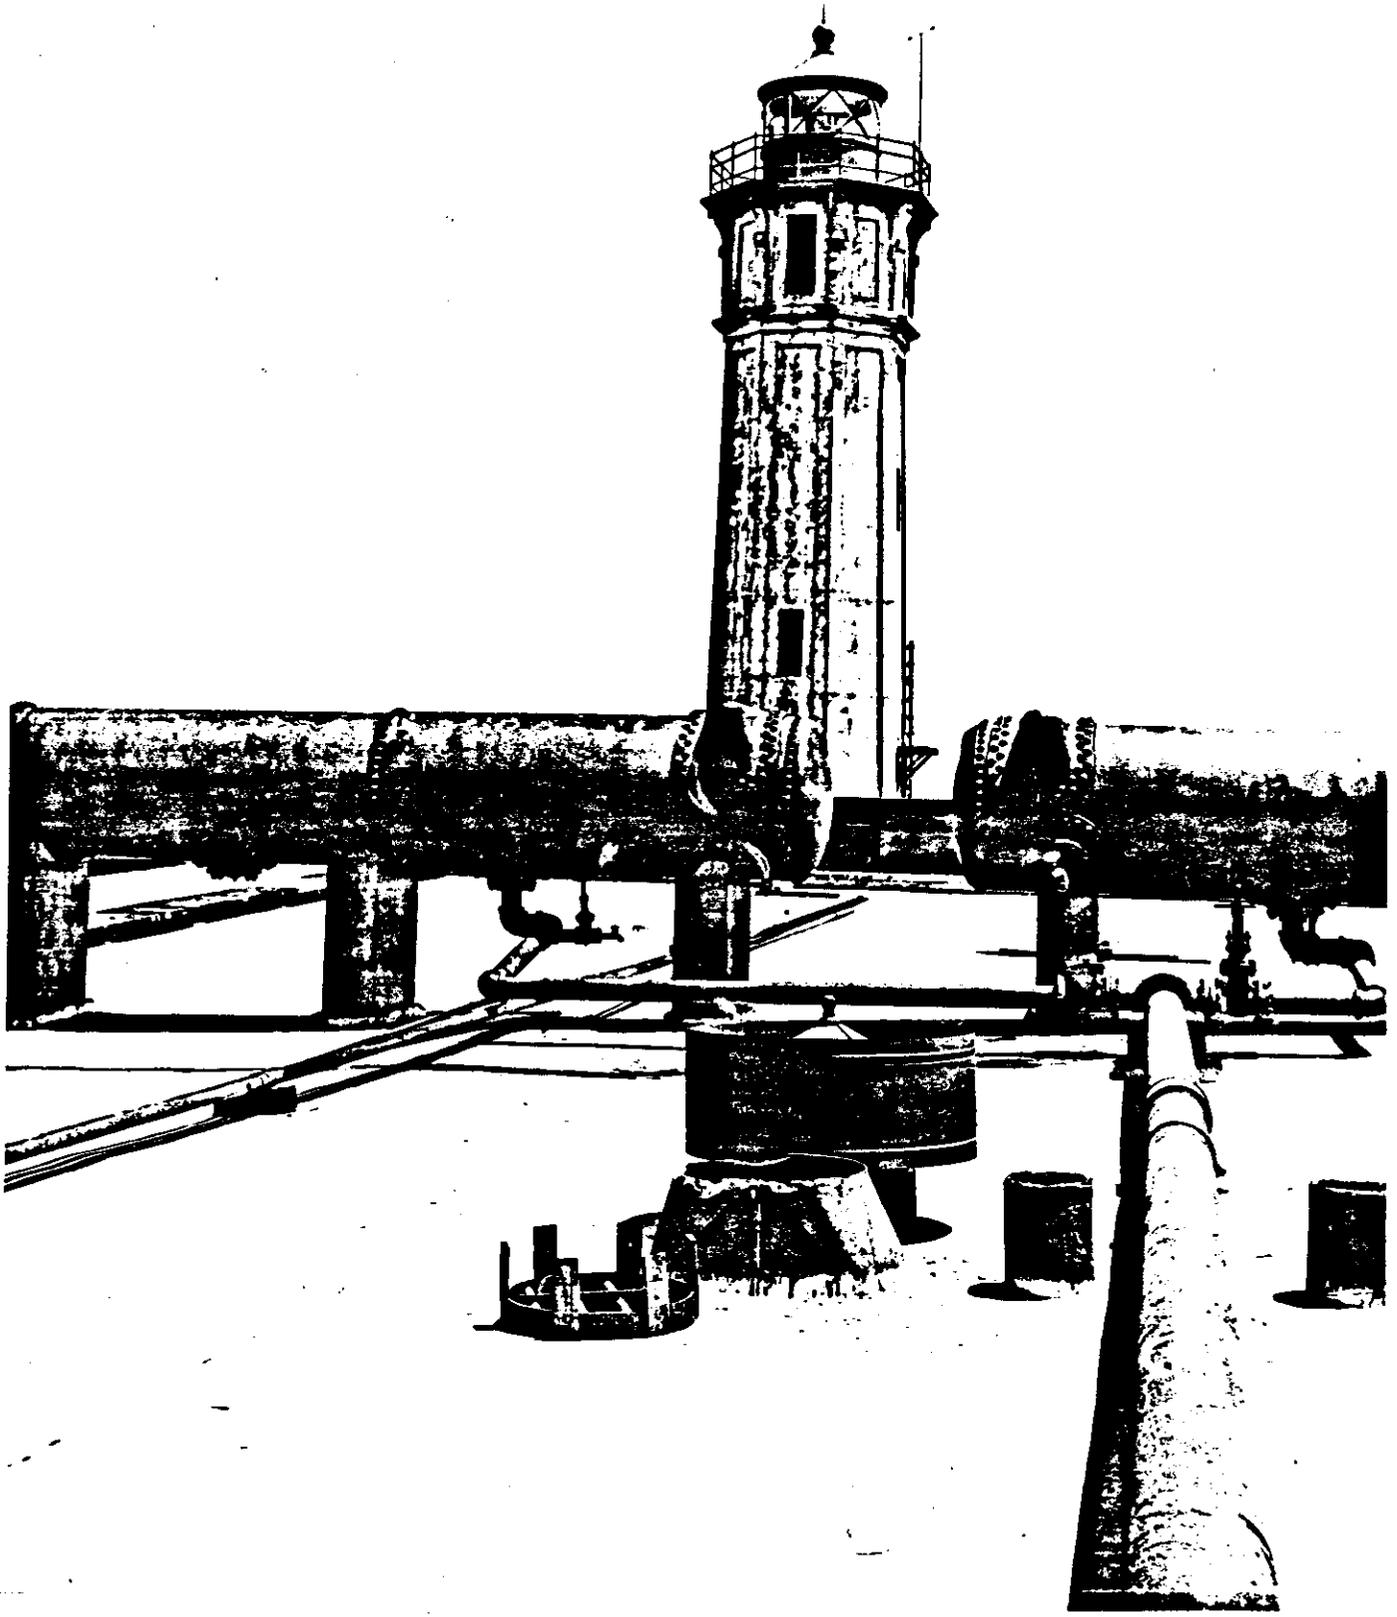
1-6 Photograph taken on the top of building comprising Cell Block B looking in a southeast direction showing general view of building top with the Coast Guard lighthouse center rear. This lighthouse is not manned except in cases of emergency.

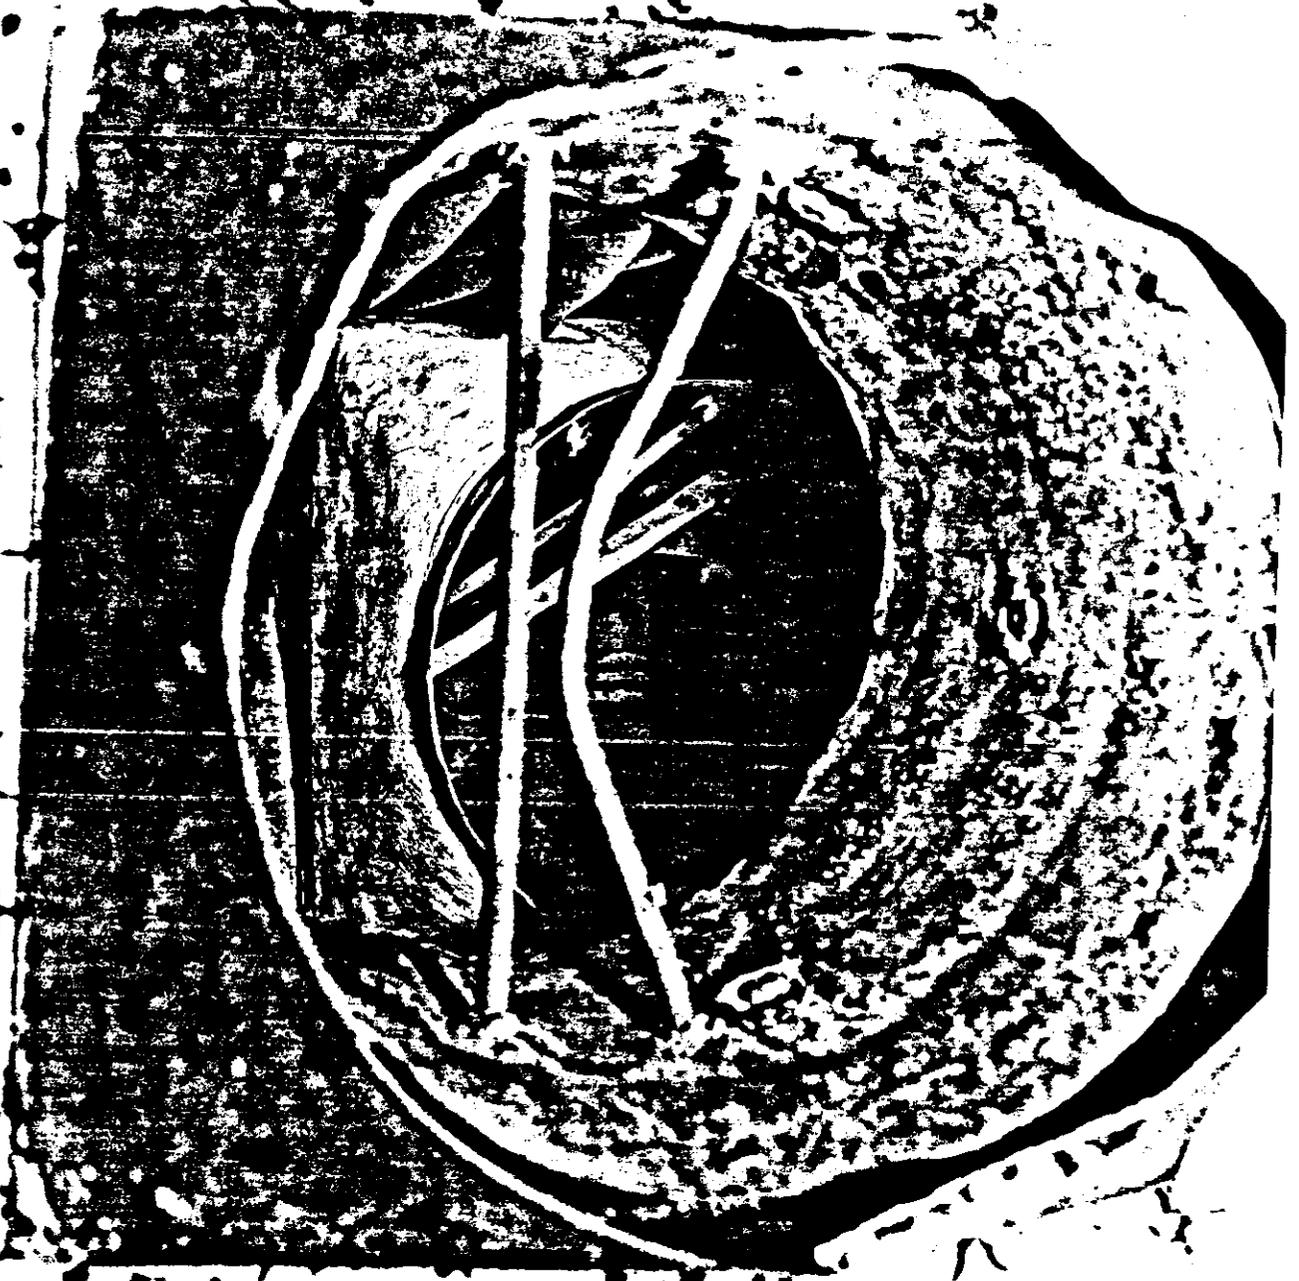
1-8 This photograph was taken directly over the ventilator opening on the roof and shows the vent re-enforcing rod and the stud holes normally used to fasten down the heavy galvanized grate shown in photographs 1-1, 2, and 3. Immediately below the opening may be seen the top of the motor housing which is normally offset from the roof opening and when in operation is joined by a galvanized gooseneck connection. The blades of the "squirrel cage" type air impeller may be seen just above the bent portion of the re-enforcing rod. The bent rod is on the eastern side of the hole.

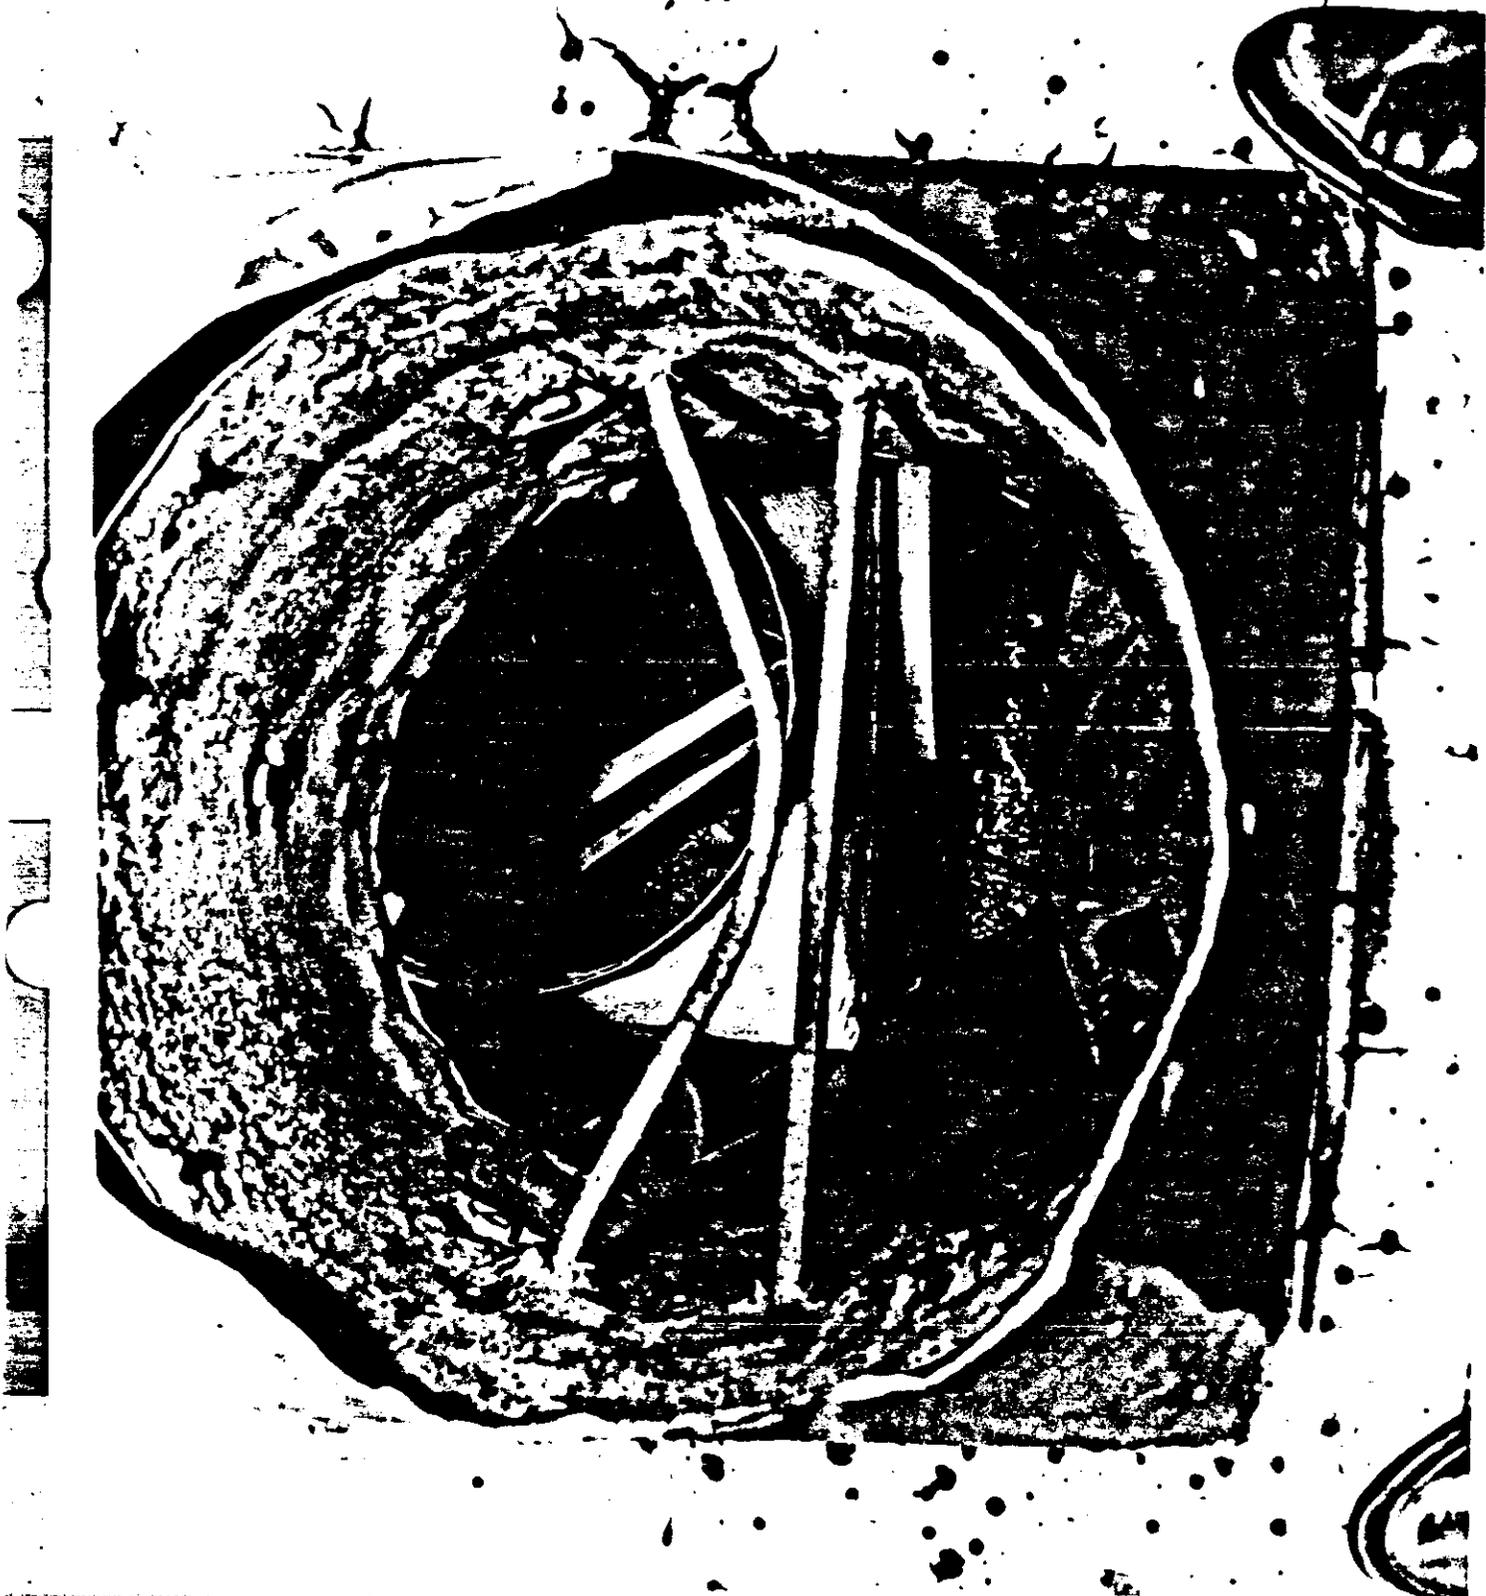
1-9 Same as 1-8 with the exception that more detail is shown concerning the blankets which were used to shield light from entering this opening.

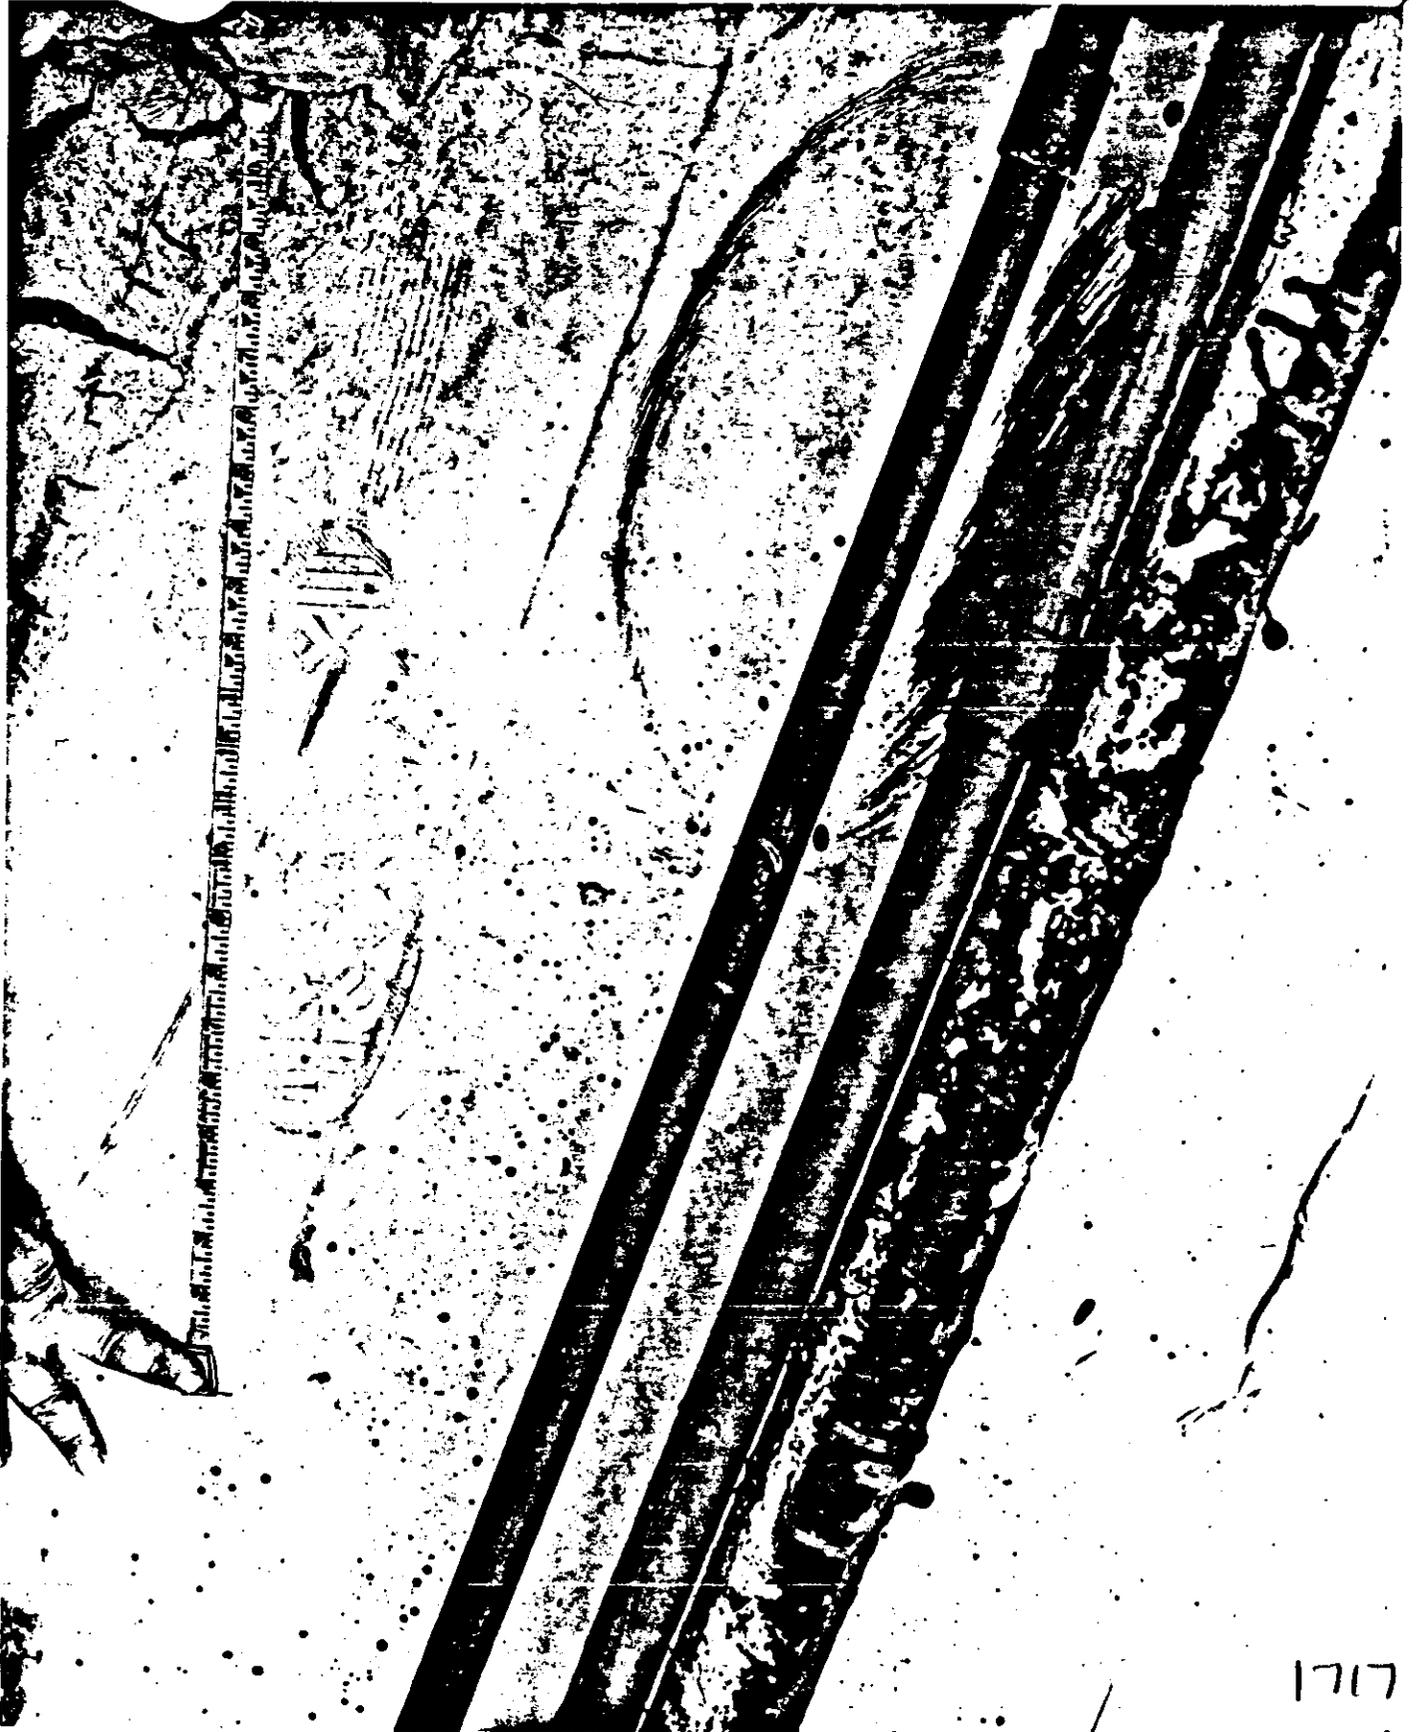
1-10 This is a photograph of an imprint of what appears to be the left foot. This print is headed in a northwesterly direction. The imprint appears to be that of the sole of a tennis shoe and is one of a number of fragmentary such prints visible on the roof indicating the direction of travel.

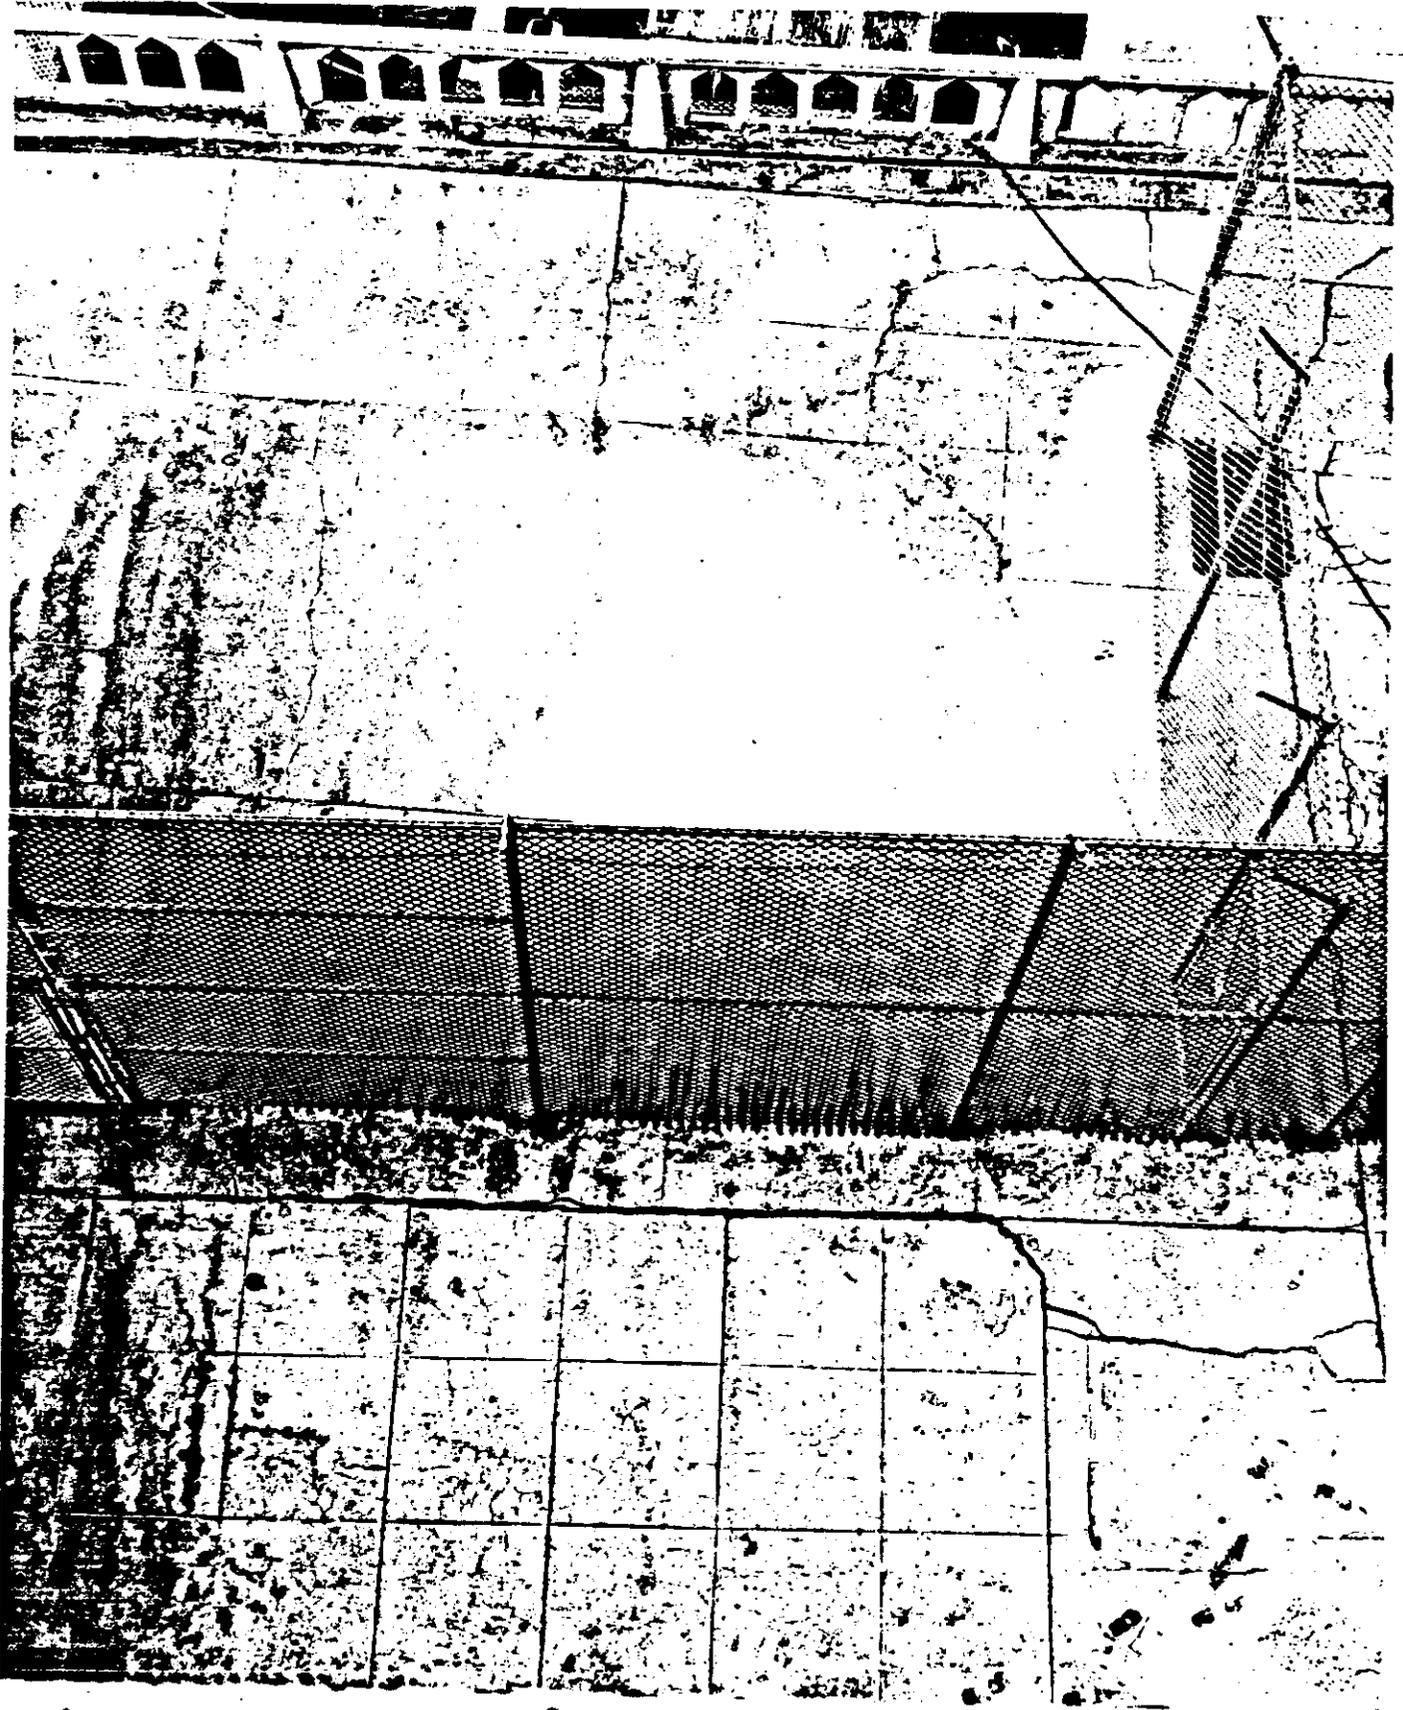
1-12 This photograph was taken from the north end of the building looking down to the enclosed ground area which is believed to be the area the Subjects descended to. The distance from the top ledge of the building to the concrete shown in the lower foreground is approximately forty-five feet.

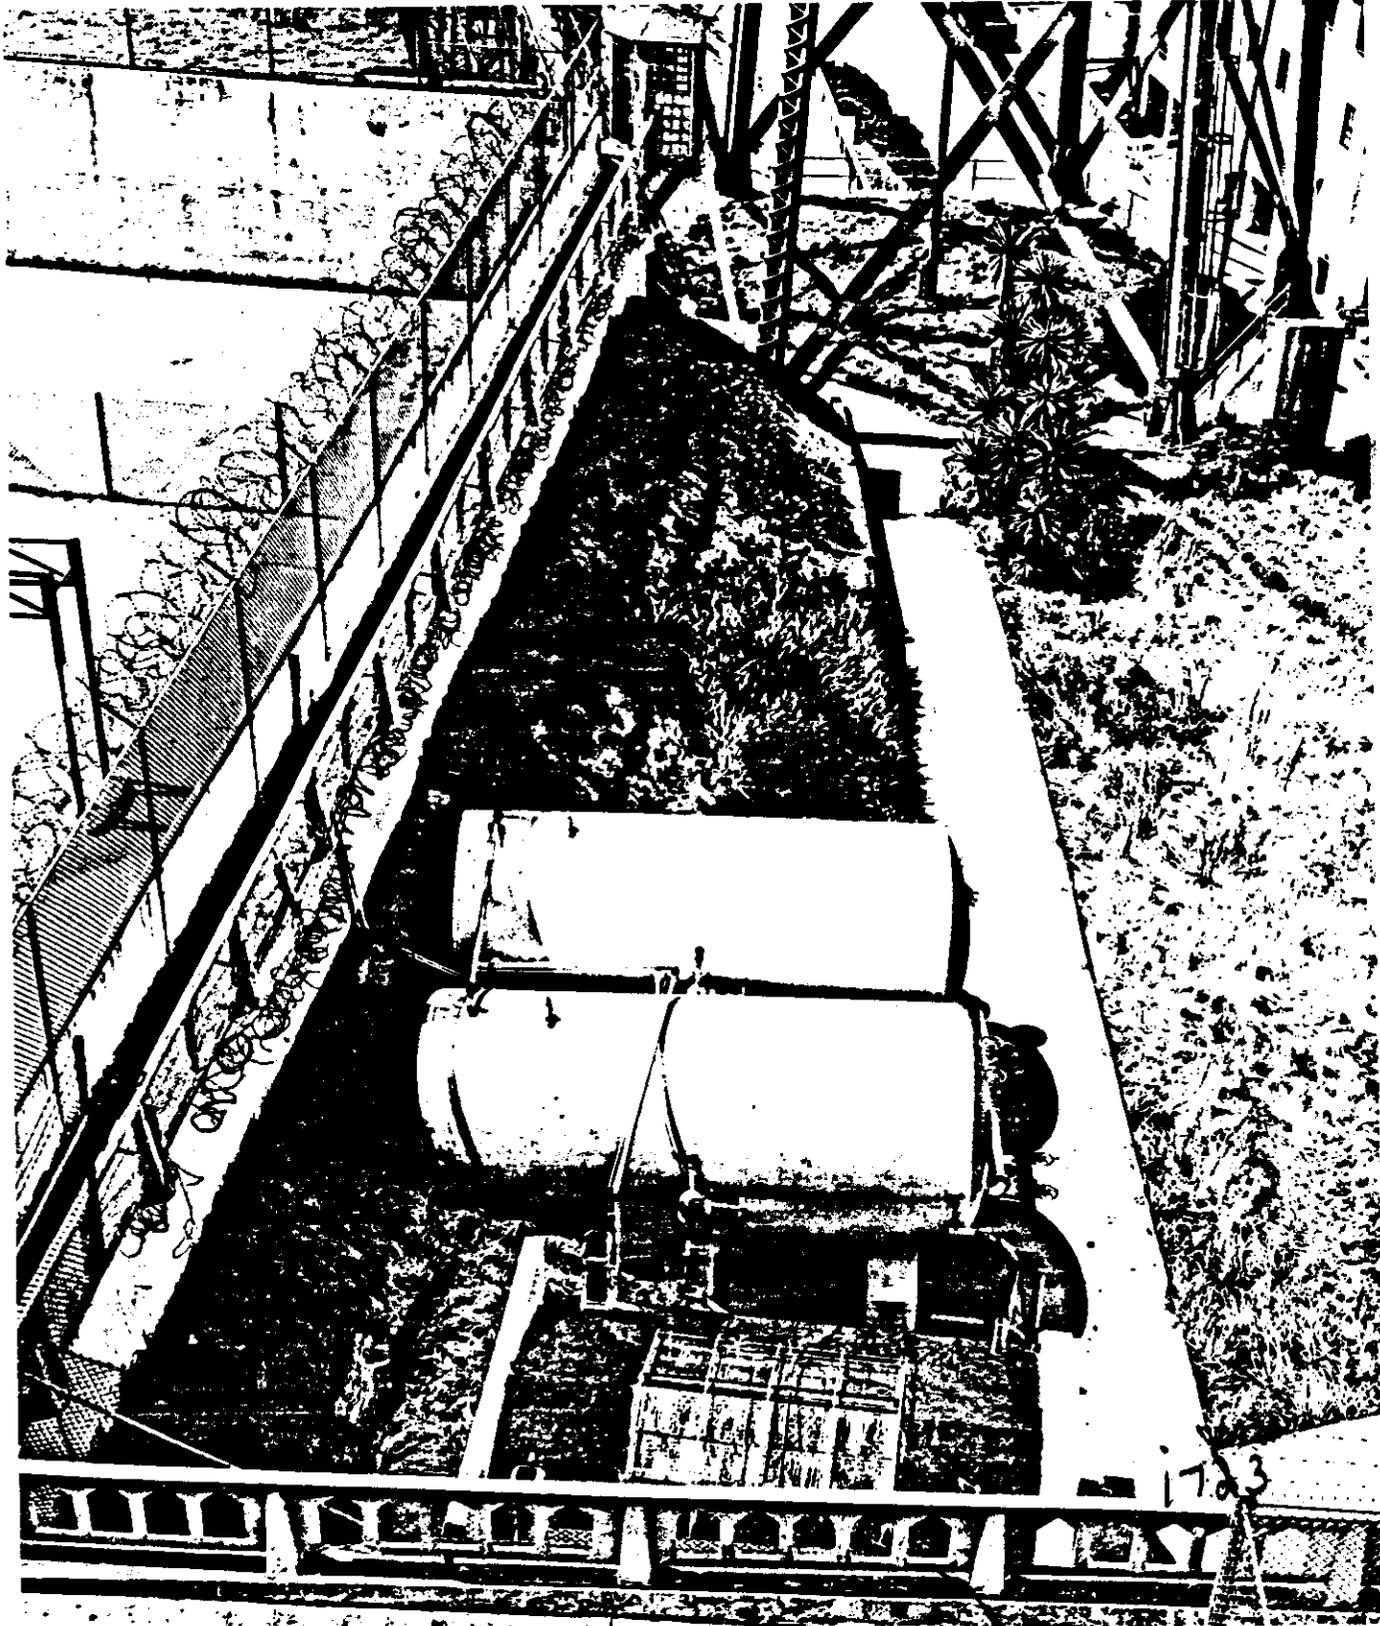
2-1 Photograph taken from top of prison building looking in a northern direction. The concrete decorative wall shown at bottom of photograph is the same as appearing at the top of 1-12. The two tanks shown in the foreground are salt water tanks with the base of the water tower shown at upper right. Top center is guardhouse number 3 and is not manned during the night hours. It is noted that lower left center along the fence, which encloses the walk to guard tower number 2, the barbed wire appears to have been cut and may have been the area over which the Subjects were able to make their escape.

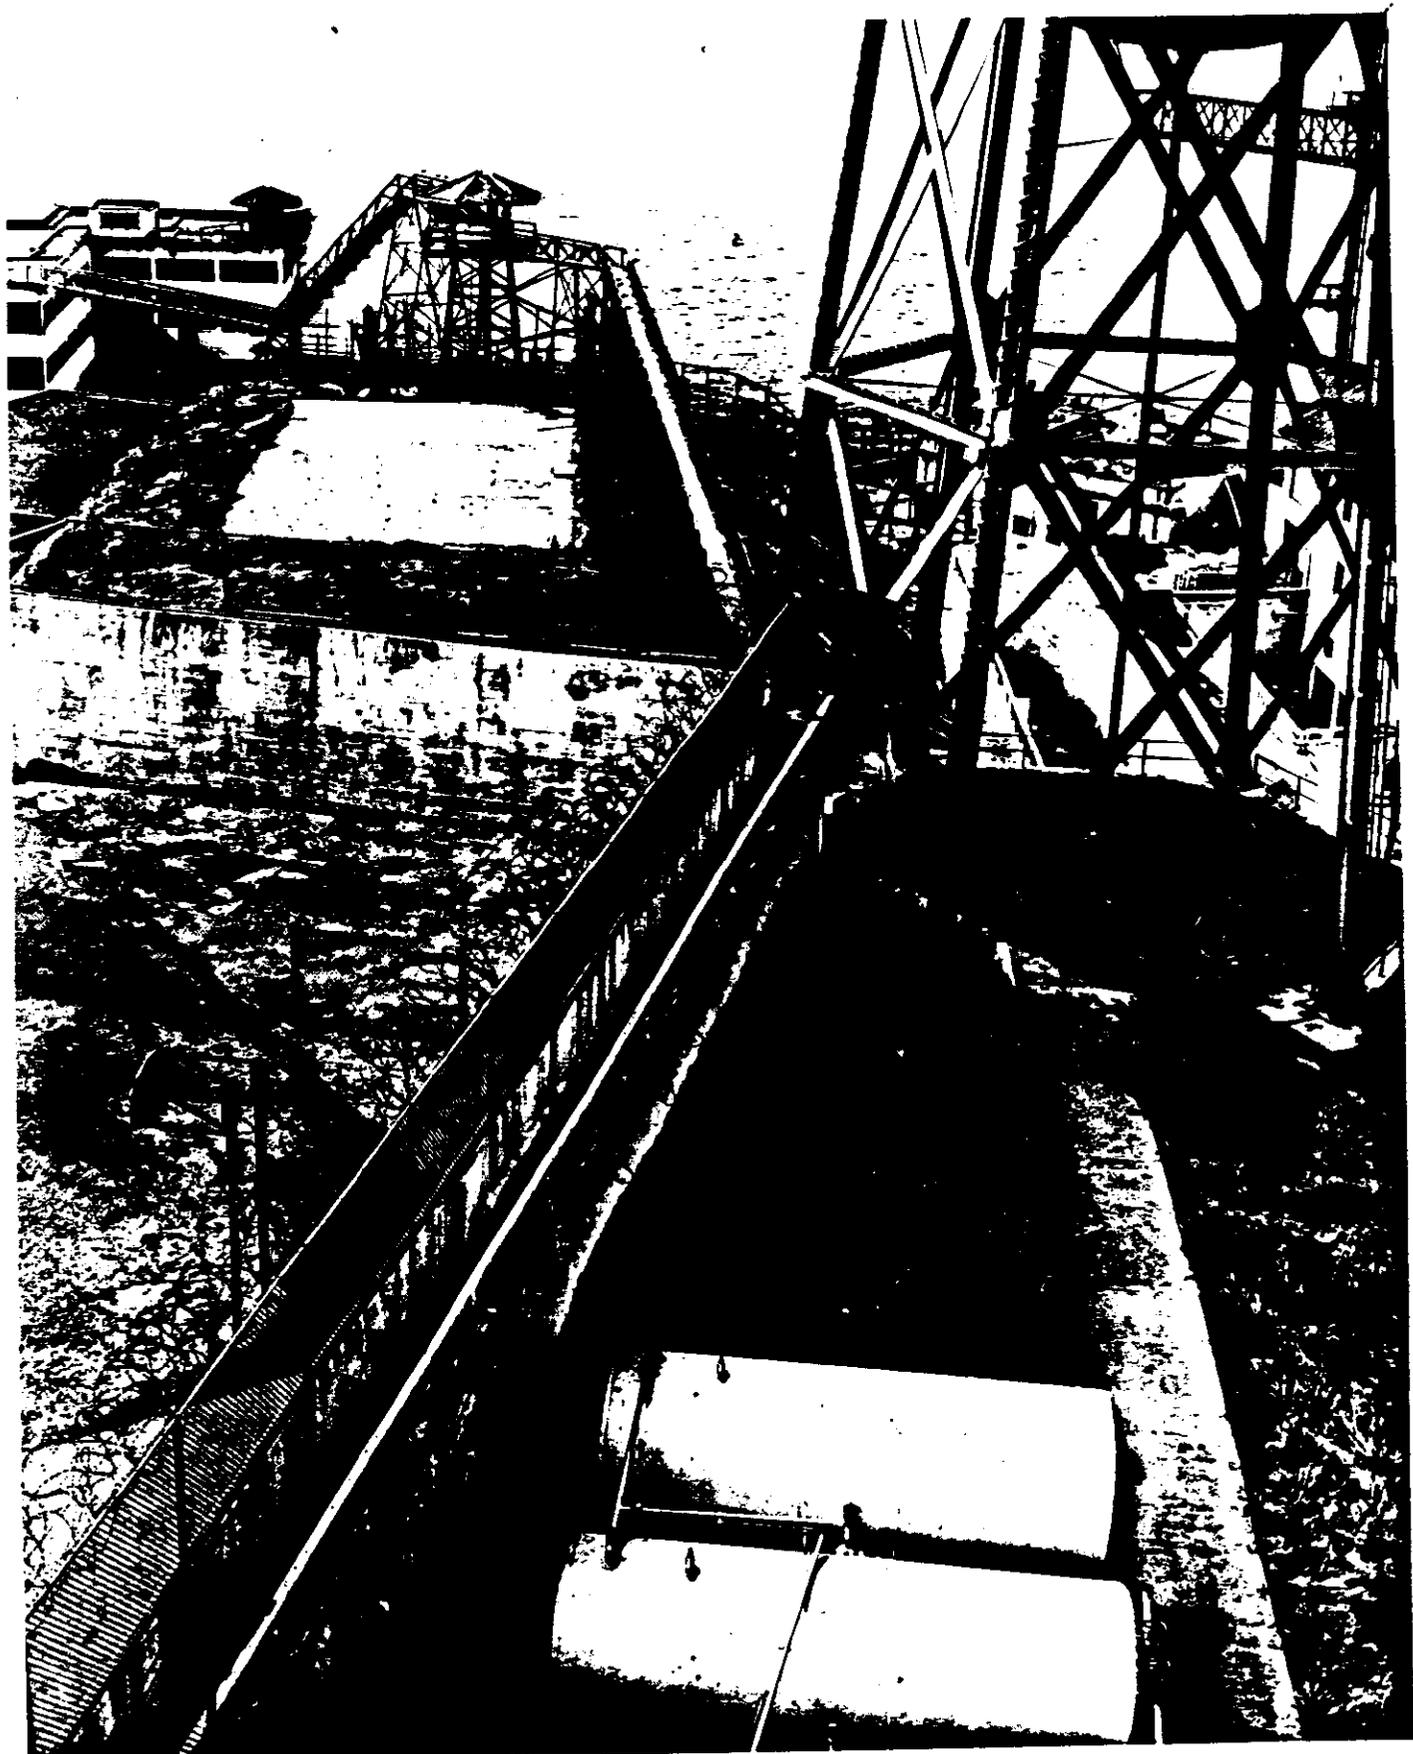
2-2 A general northern view taken from the top of the prison building. The area immediately to the left and center is the recreation area and at the far end may be seen guard tower number 4 and guard tower number 3 and guard tower number 2. None of these guard towers are manned during the night.
