SUBJECT John Anglin, Clarence Anglin and  
Frank Lee Morris Escape from Alcatraz

FILE NUMBER 76-26295

VOLUME NUMBER Enclosures 76, 137, 155 and 179

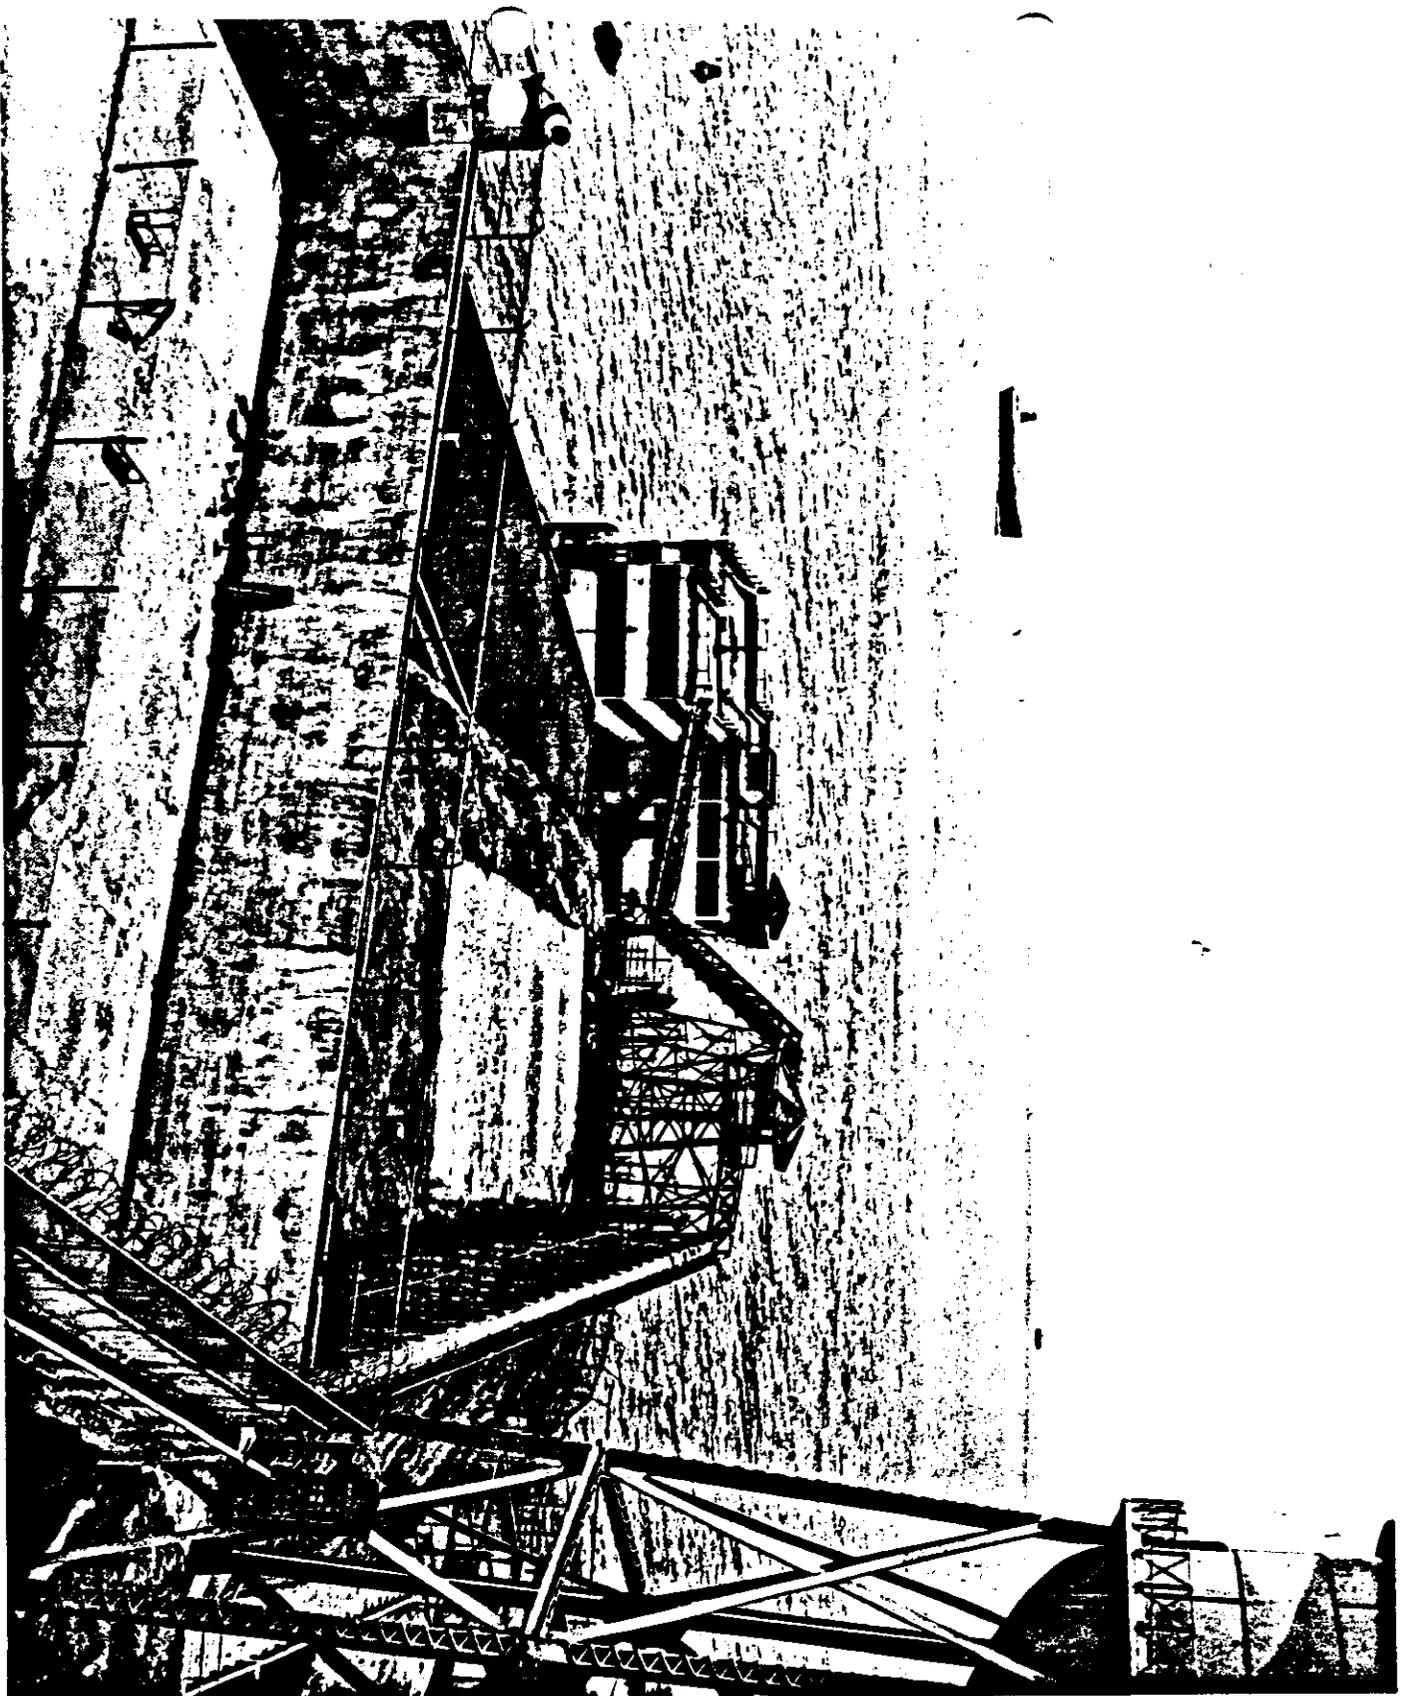
2-3 Same general view as 2-2 except that a larger portion of the recreation area is visible.

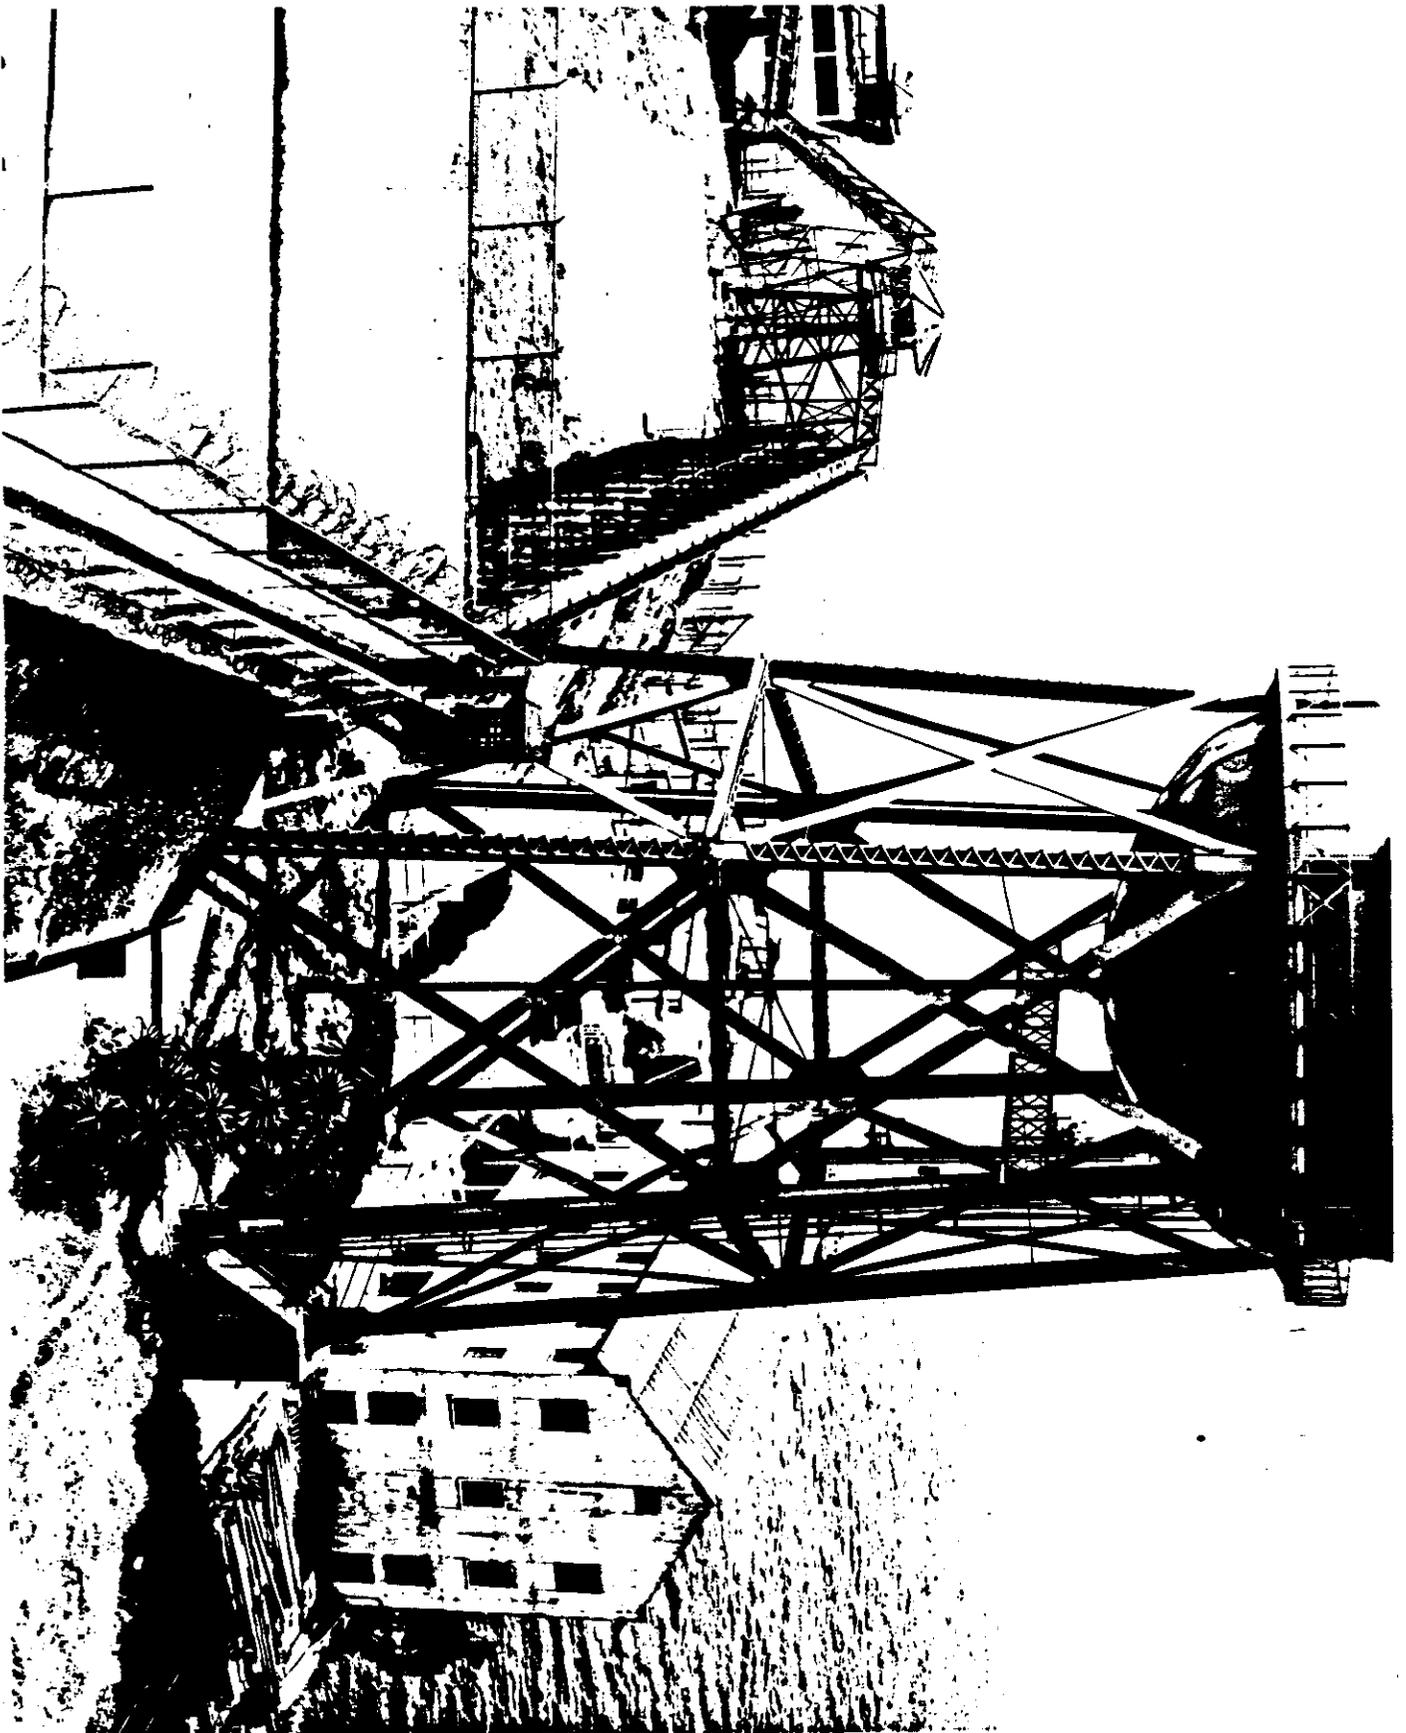
2-4 Same general view as previous photographs with the exception that the industrial building is shown in more detail.

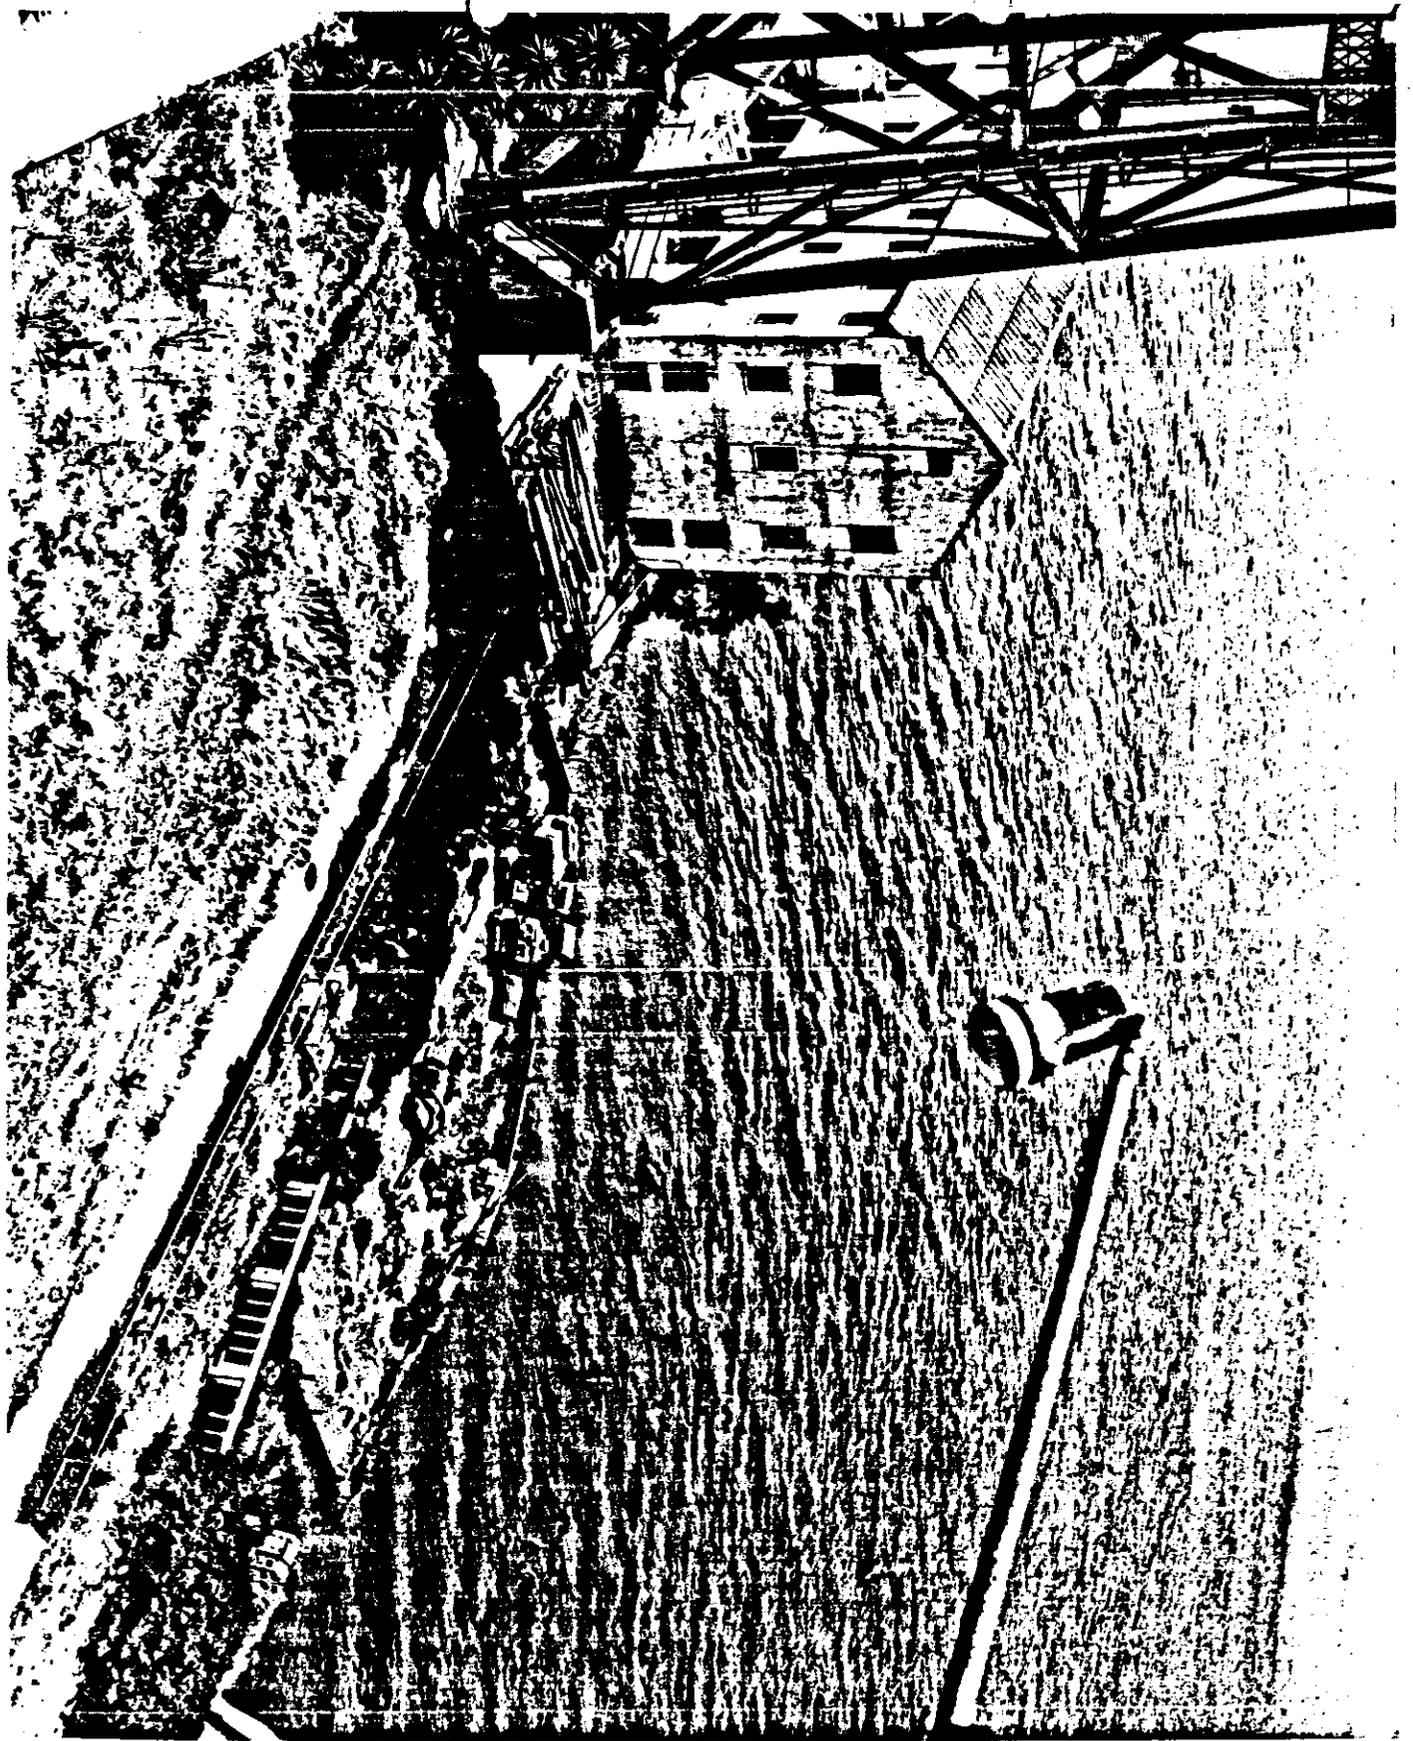
Photograph taken from roof as in preceding photograph, however this photograph shows the type of electrical fixture used to flood the sides of the building with light during the evening hours. Two such lights are spaced across the narrow or protruding end of the prison building and are spaced approximately ten to twelve feet apart. These lights receive their power from an externally mounted outlet on the inside of the edge of the roof and all connections were found to be tight and show no indications of having been tampered with. All lights were found to be in working order and were illuminated at the request of the photographer. The area at lower right is leading to the water line. It is the area believed to have been used by the Subjects in reaching the water.

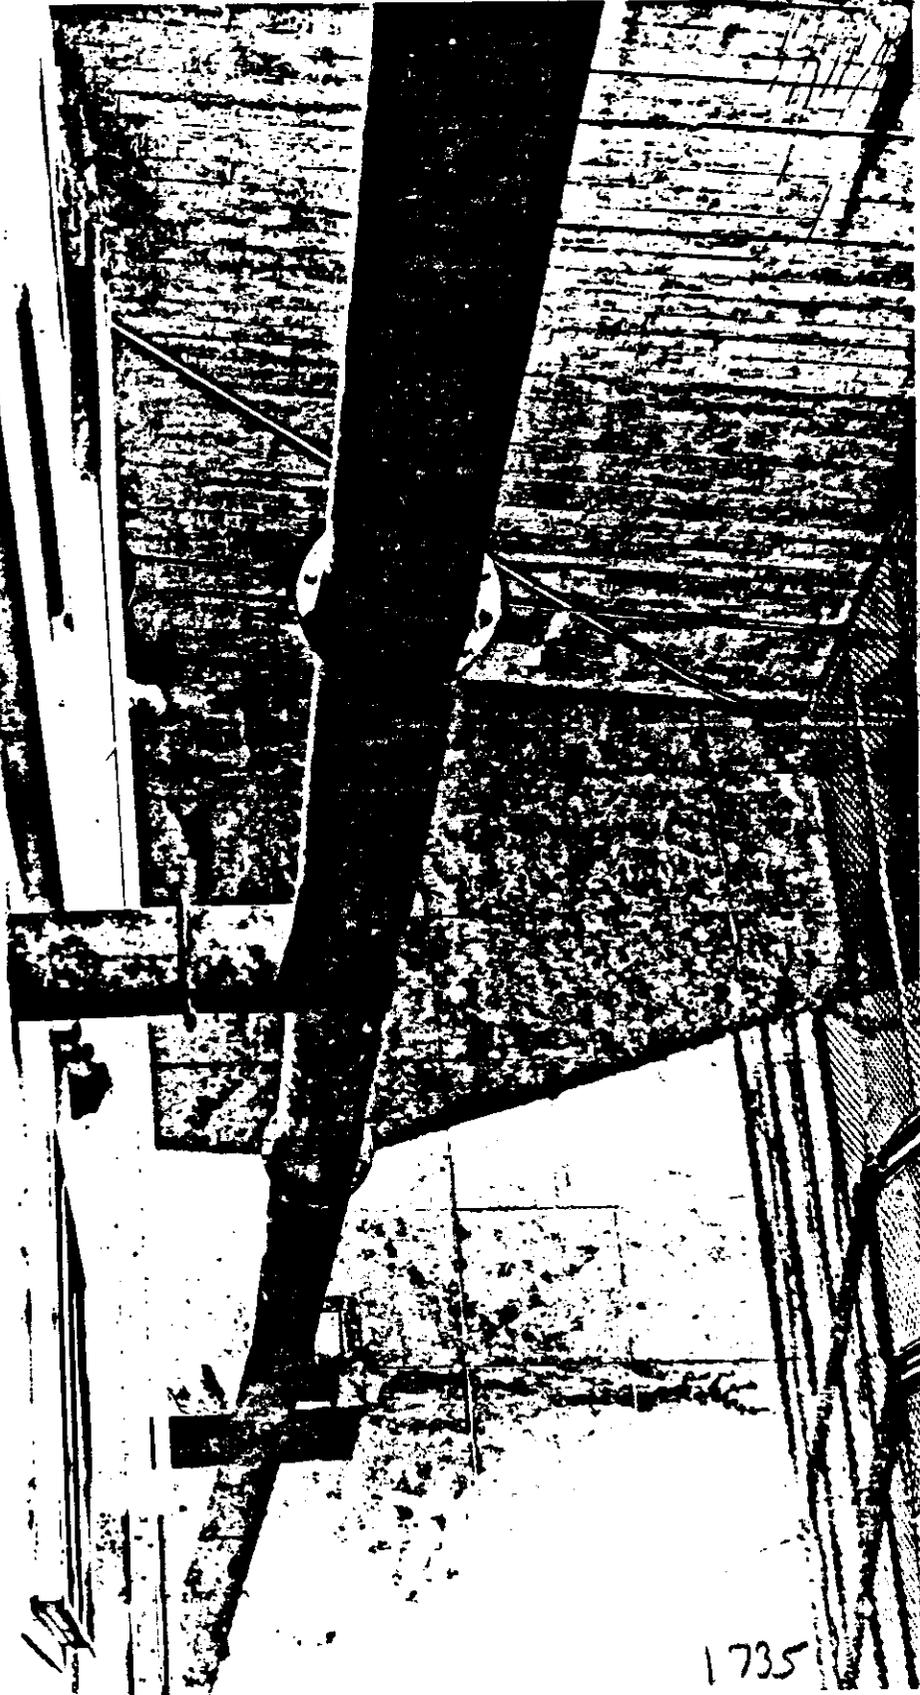
2-7 Photograph taken by leaning over the edge of the building showing the bake oven stack extending from above the roof line to the clean out on the concrete slab at ground level. The edge of the building is at left center and the distance from this to ground level is approximately forty-five feet. The wire screen topped with barbed wire seen at lower right is approximately twelve feet high.

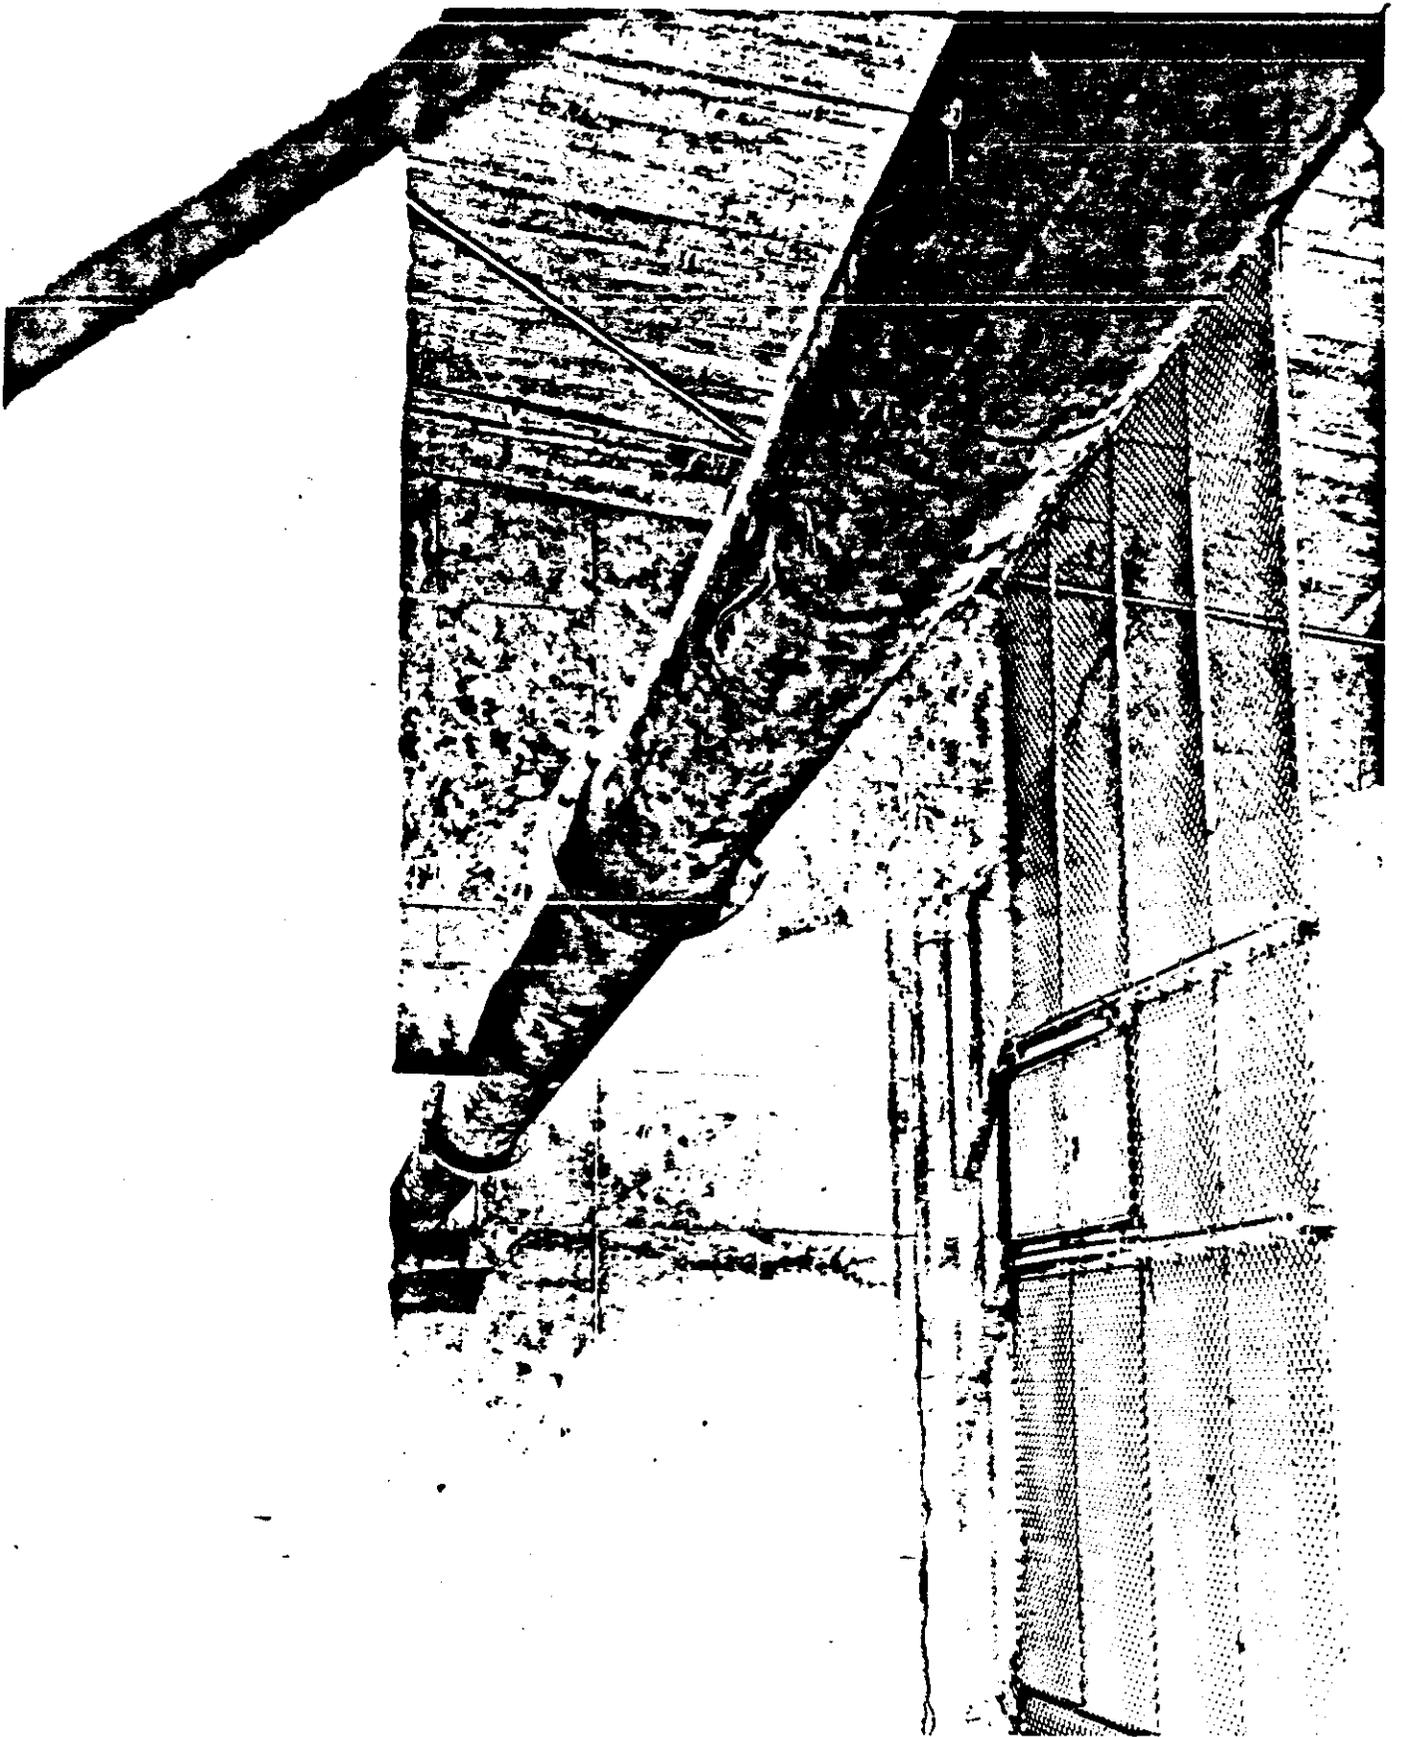
2-8 Same general view as 2-7.

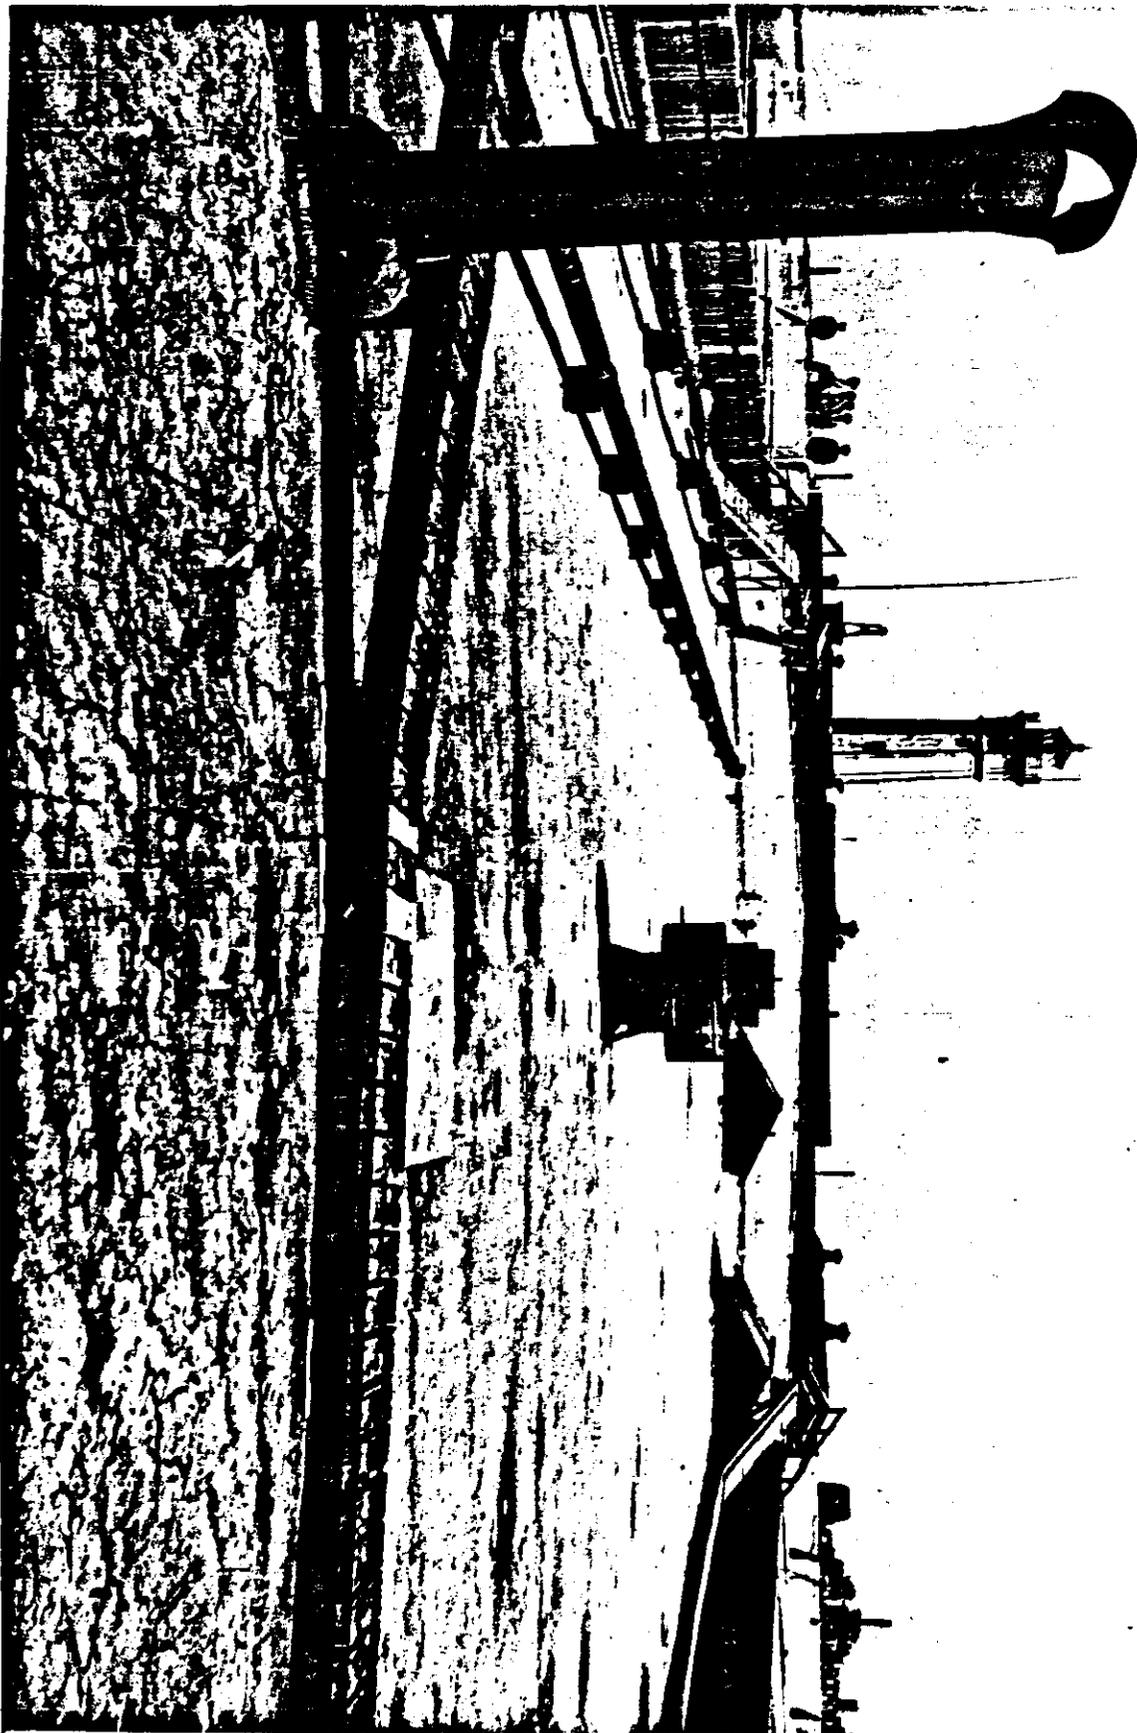
2-10 Photograph taken showing general roof area looking in a southerly direction from the bake oven stack toward the Coast Guard lighthouse. The change in the roof elevation from Cell Block A, B, and C, etc., may be observed with catwalks running on both sides of the picture. A paddle was found under the catwalk in approximate location indicated by the individuals seen in the photograph left center.

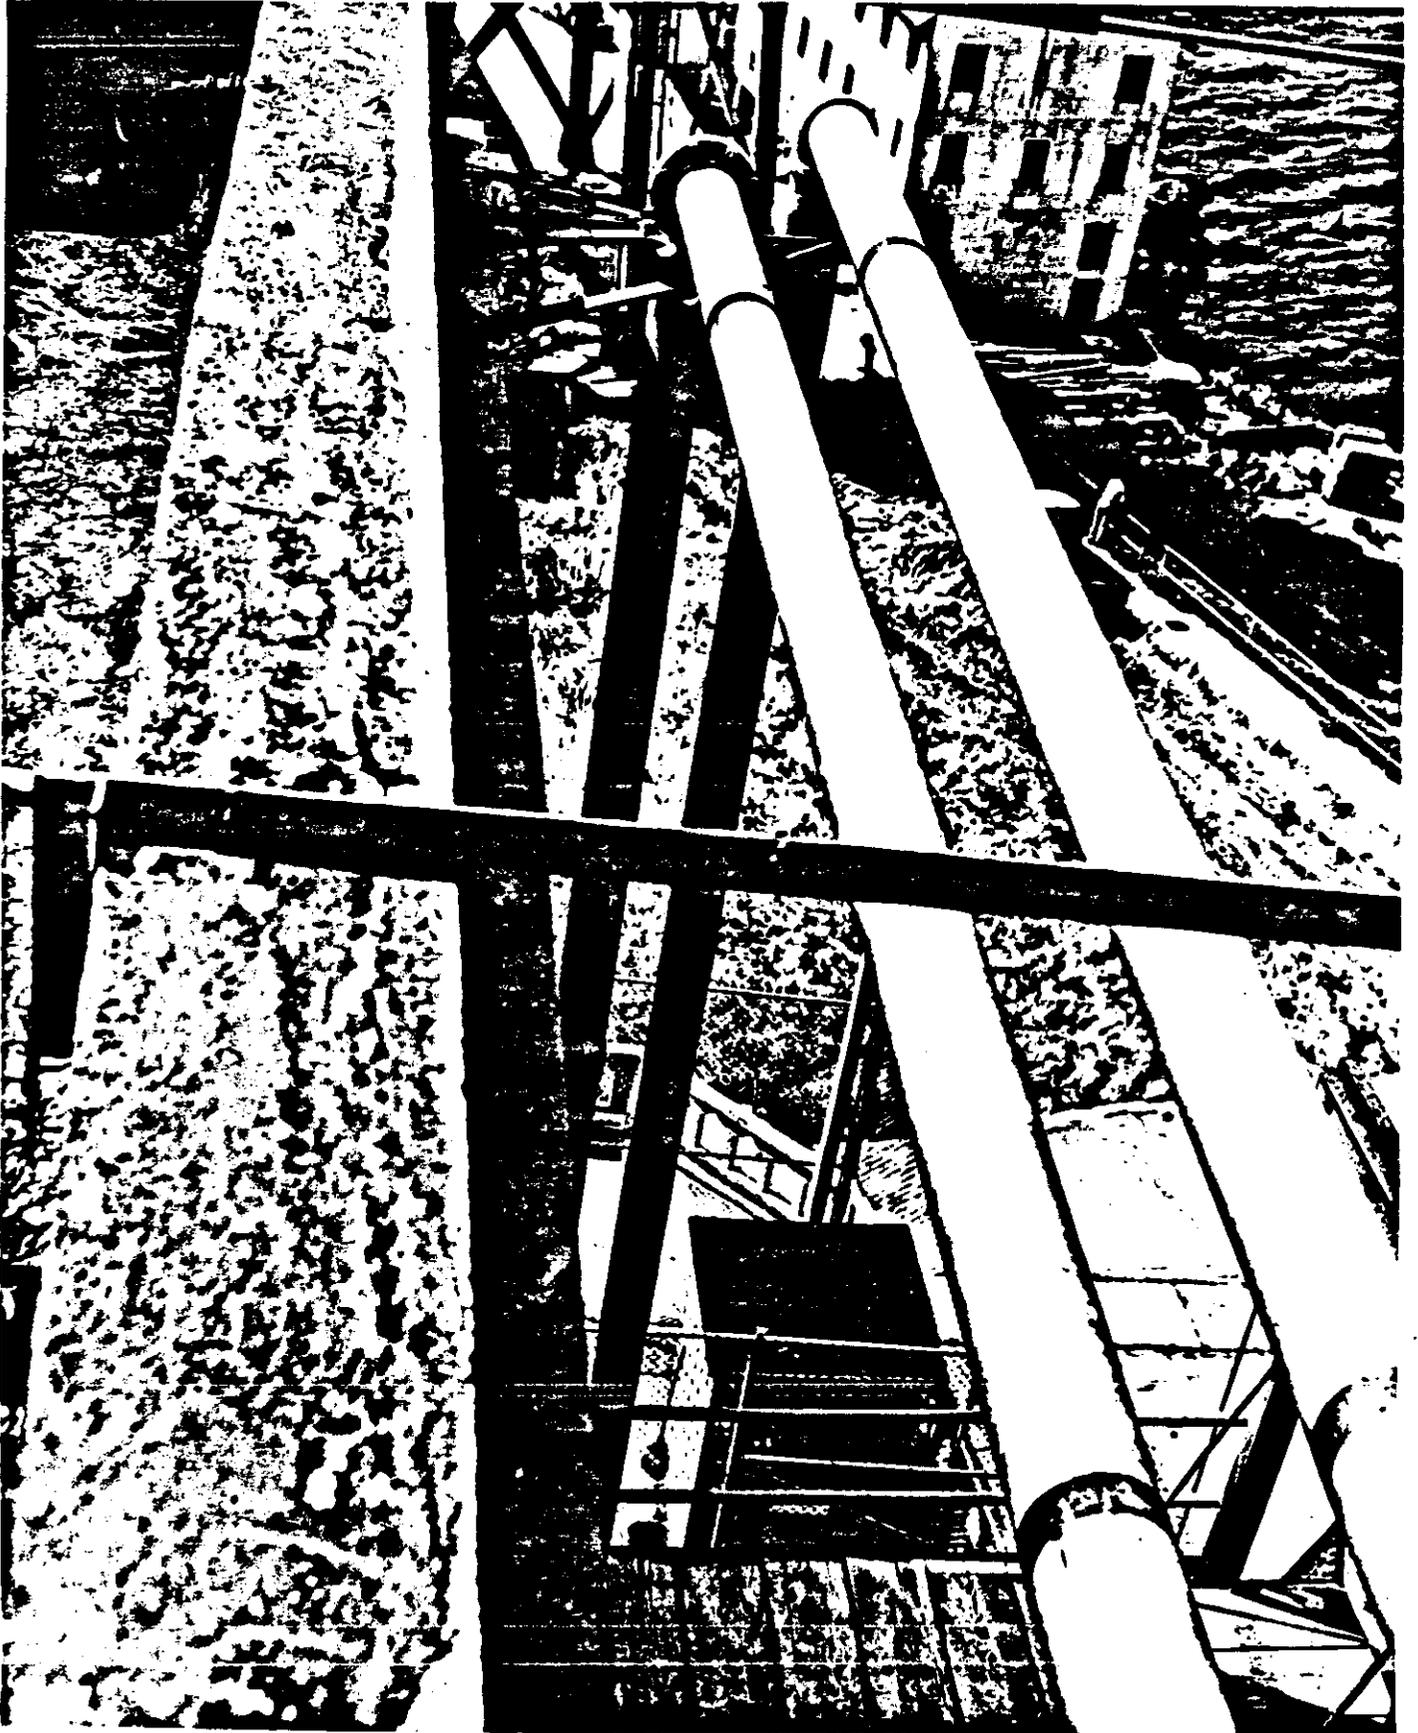
2-11 - Photograph taken from roof of building at the northeast corner showing aluminum-plated utility pipes descending to ground level. These pipes are approximately six inches in diameter. Lower center of photograph shows the landing outside of the third floor entrance to the prison building. Stairs lead from this landing to the ground level in the same area as shown in photograph 1-12, however this corner of the building is illuminated by three flood lamps and is clearly visible to the guard in tower number 1 which is manned twenty-four hours a day. The angle iron crossbrace shown in the center of the photograph is the type used to support the illumination. Upper left hand corner shows the type of electrical connection for these lamps.

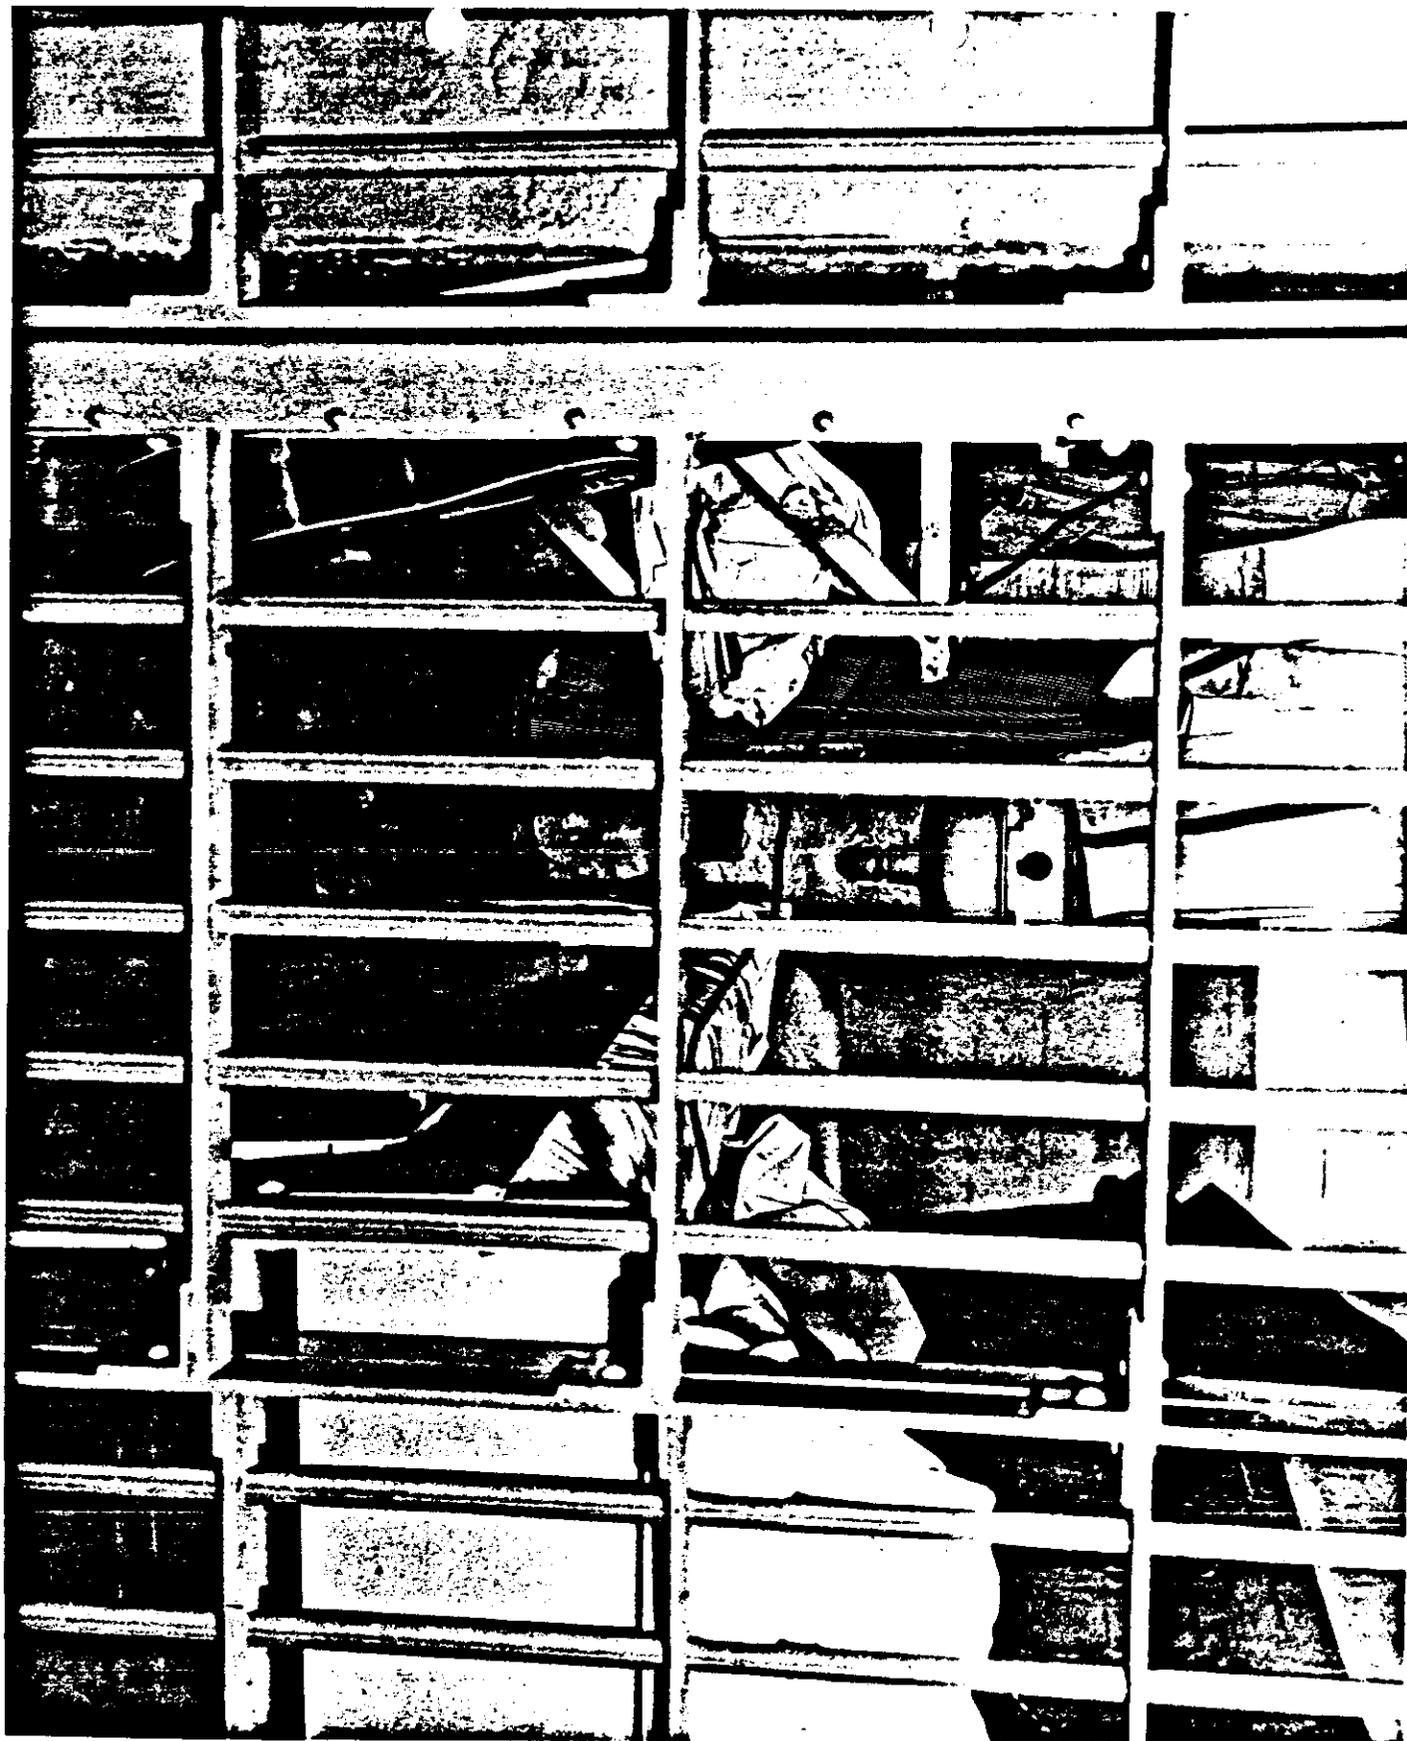
~~3-2~~  
3-2

3-2 Photograph of the same cell taken head-on showing the opening at the rear of the cell under the wash basin which permitted Subject CLARENCE ANGLIN to escape. In this photograph the hole is partially covered by a piece of cardboard, the source of which and use of which is unknown.

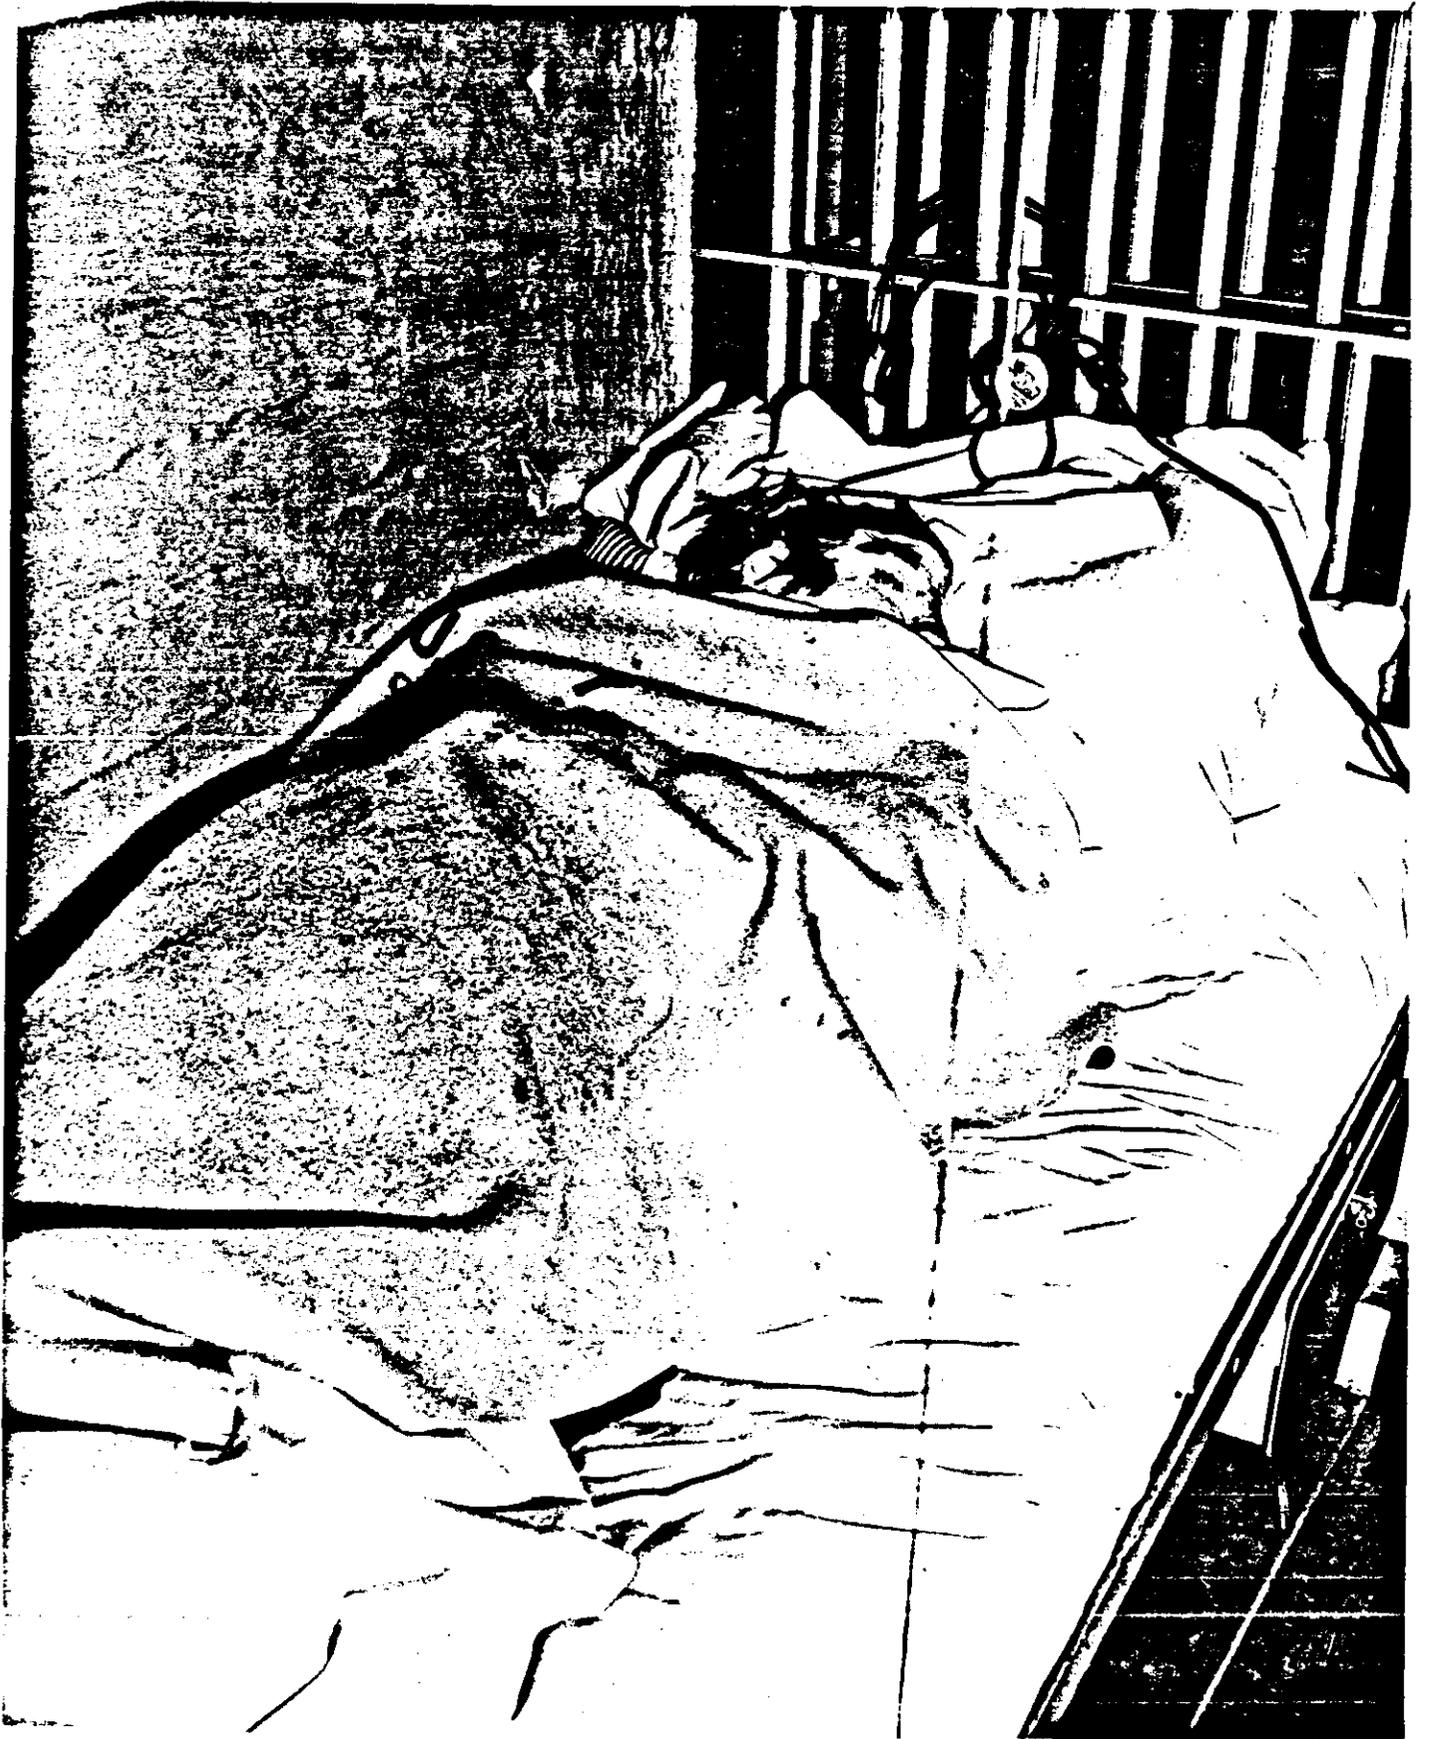
3-3 Photograph taken in Cell 152 B from foot of bed looking toward head of bed.
