SUBJECT John Anglin, Clarence Anglin and  
Frank Lee Morris Escape from Alcatraz

FILE NUMBER 76-26295

VOLUME NUMBER Enclosures 76, 137, 155 and 179

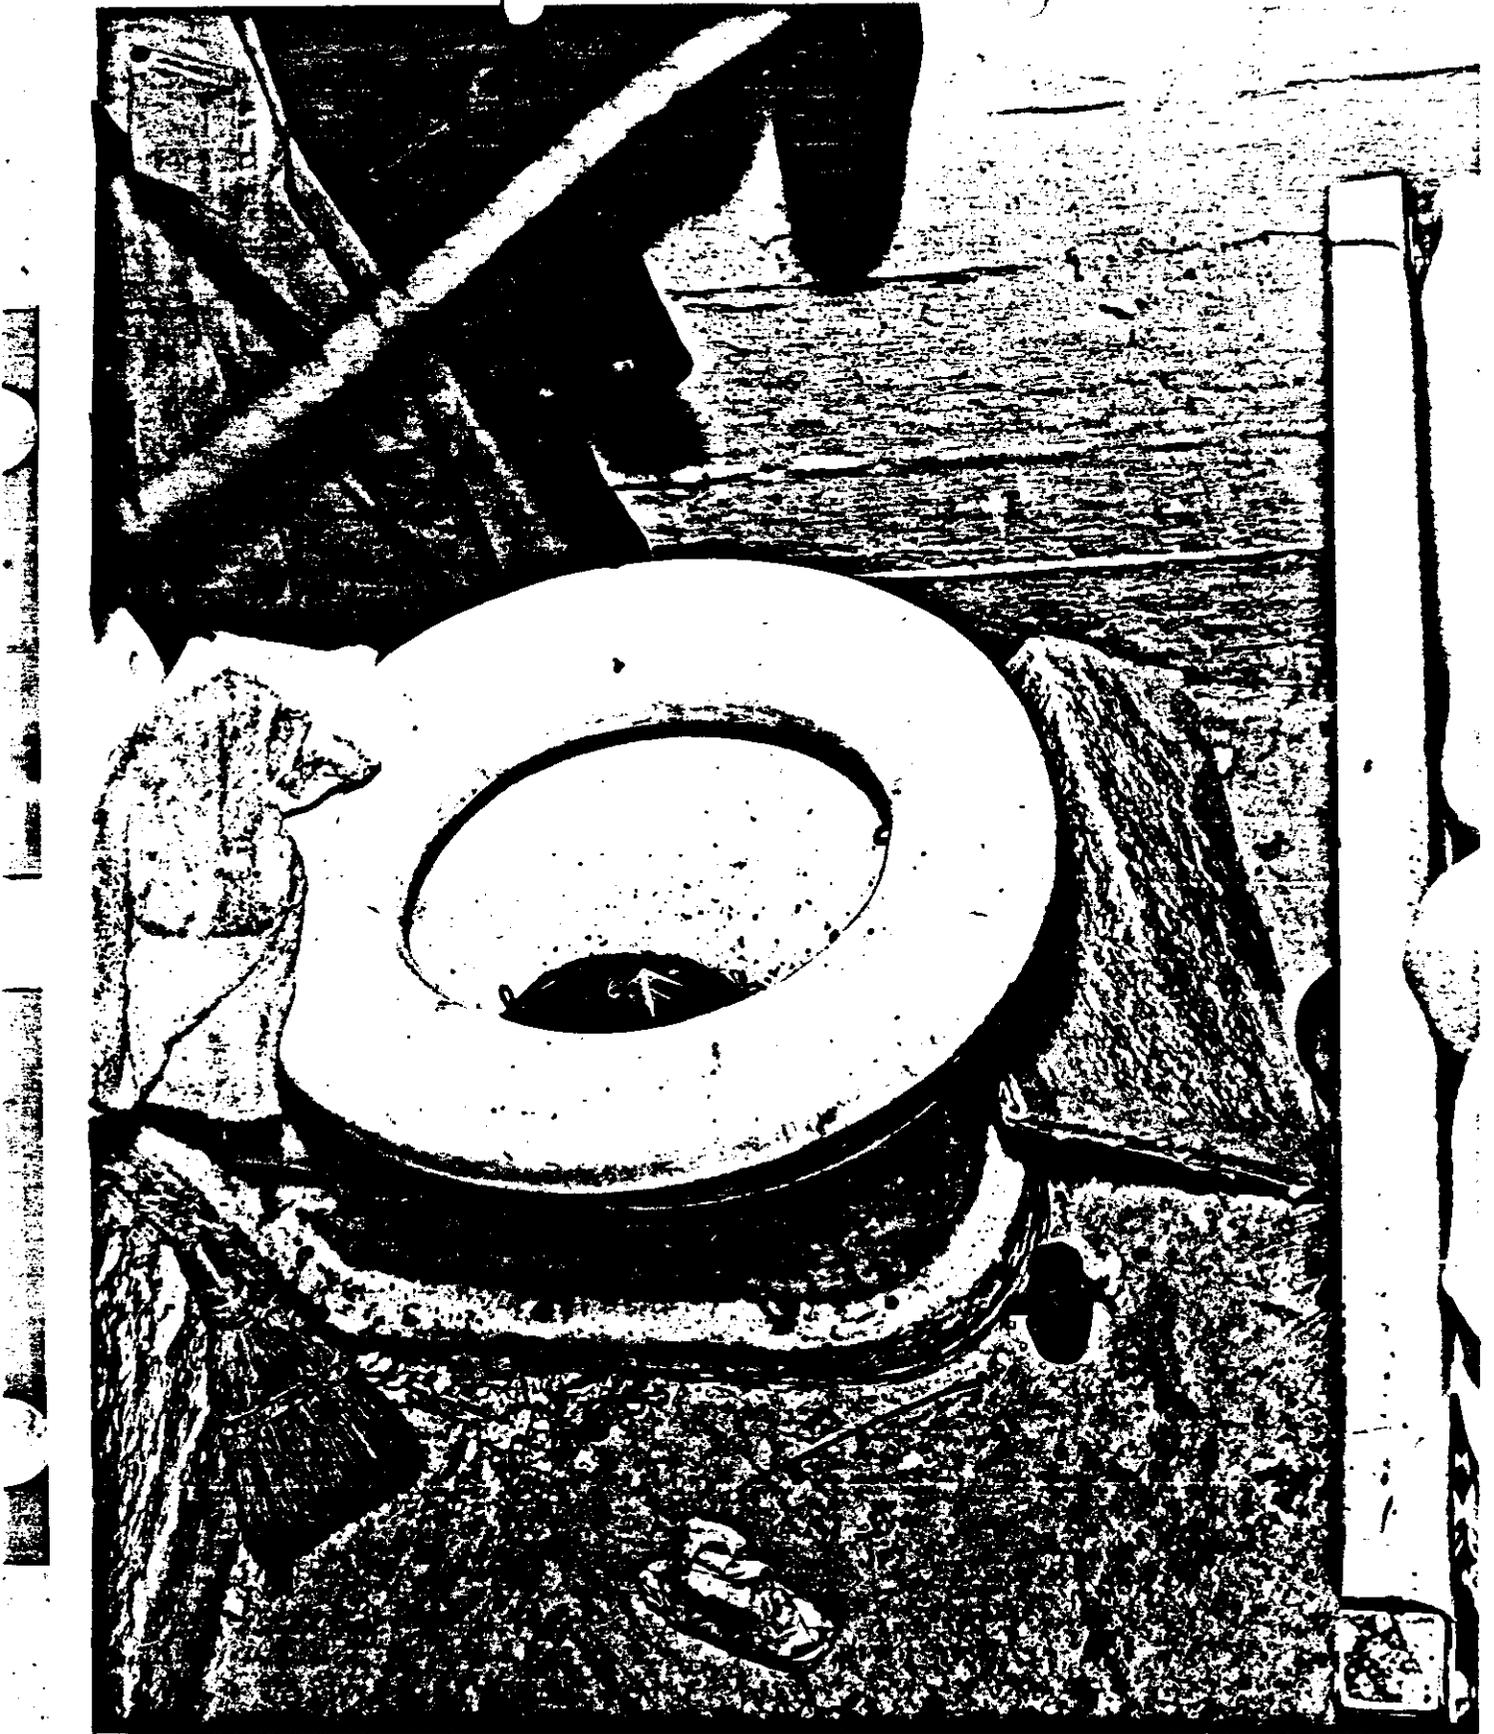
3-4

Photograph taken in the cell of CLARENCE ANGLIN showing detail of toilet facility at foot of bed. Portions of soap scraps and plaster are visible as are fragments of hair. Immediately forward of the toilet seat is a portion of the grill made by Subjects to replace that removed from the cell. The portion of the small circular object seen is the cup which is supplied to prisoners for shaving purposes. This cup contained water and a brush.

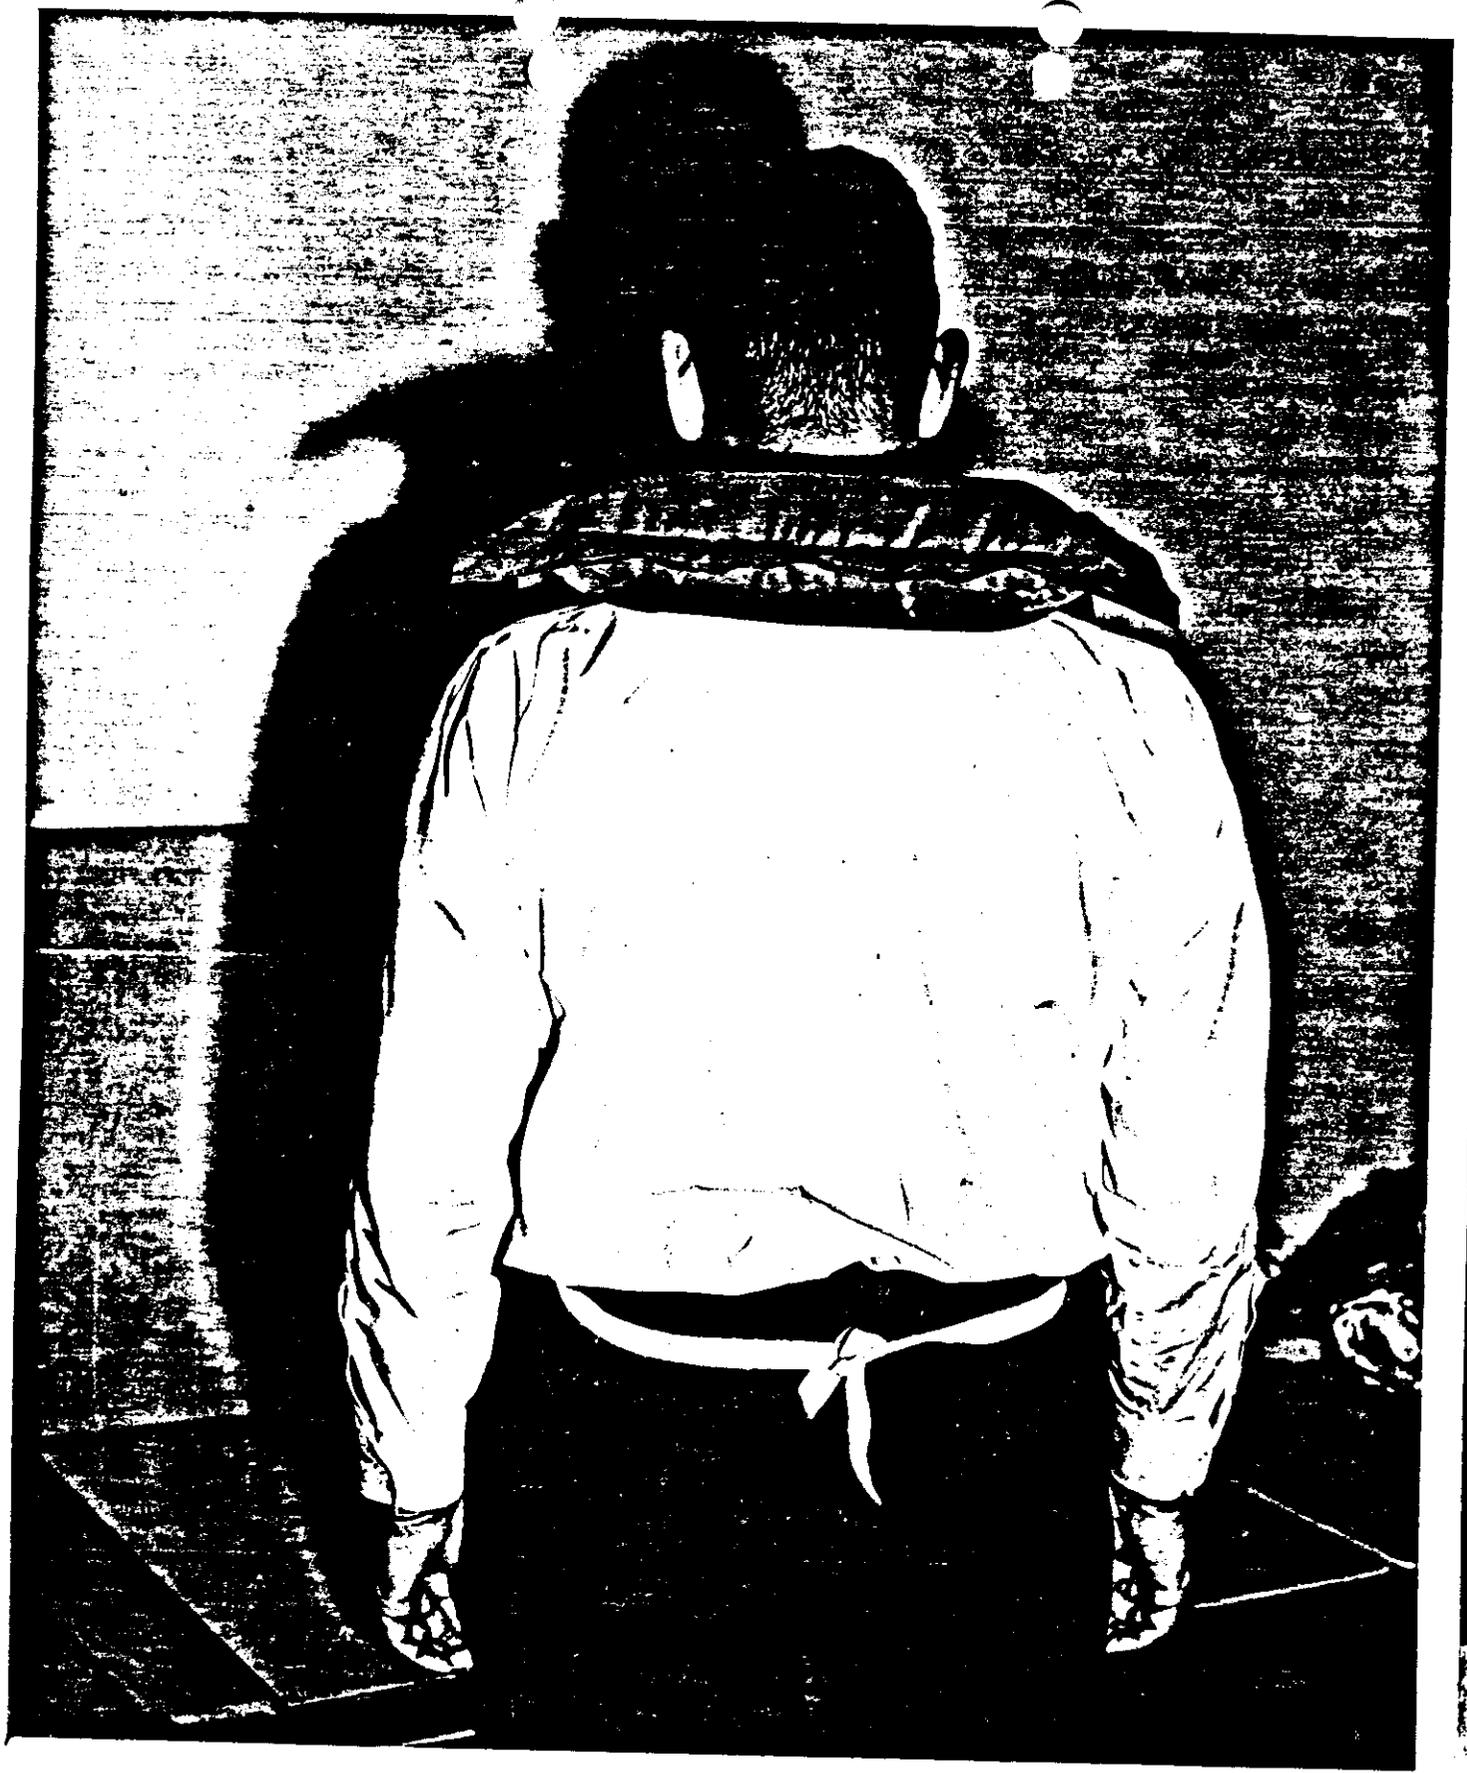
Rear view of yoke type vest being modeled by Special Agent.

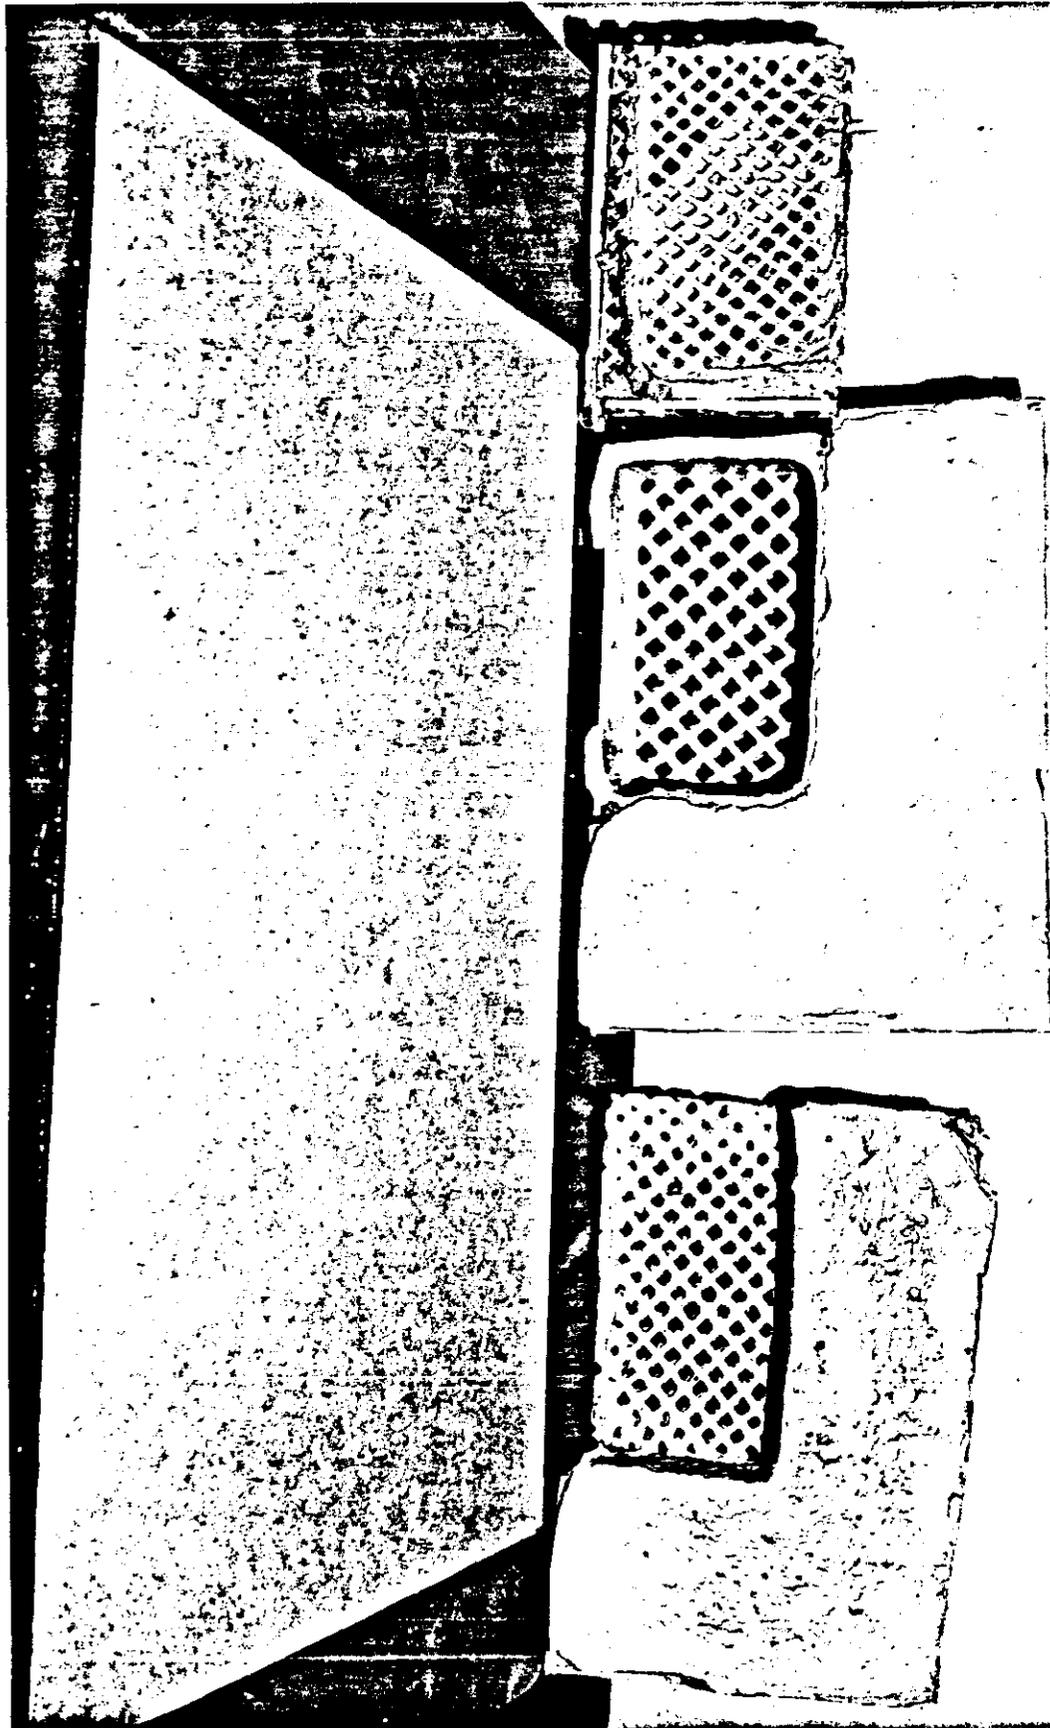
Replicas of ventilator grills placed in openings in cells through which Subjects exited to utility area between cell blocks B and A. Replica on the left is the actual size of the metal grill originally in the wall; it was reproduced, as were all the rest, from artist's drawing board which was faced with a linen-type substance. This material is available to all inmates for art painting purposes.

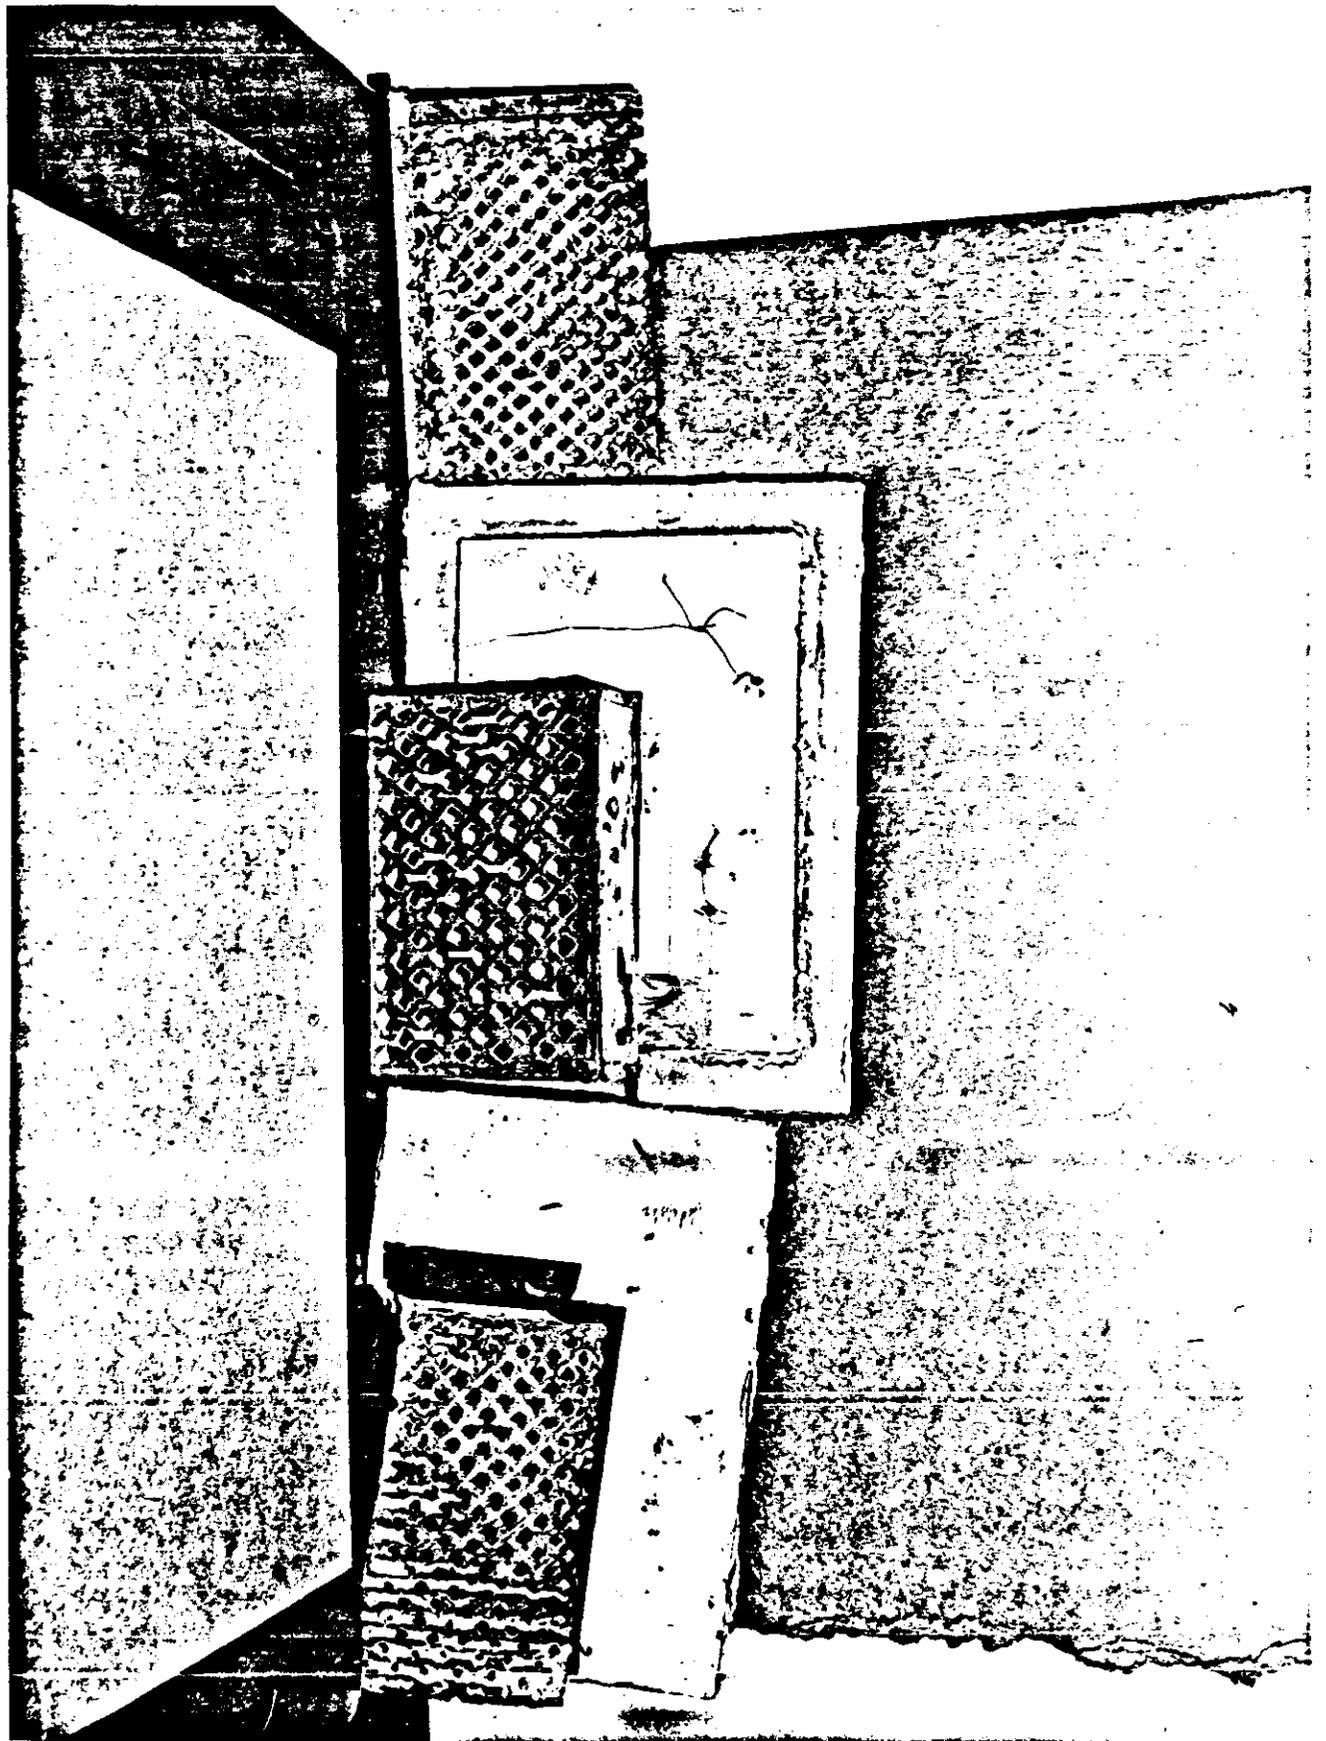
Rear view of three replicas of ventilator grills used by  
Subjects to replace original grills in their three cells.  
Note wire hooks by which grill and surrounding surface  
could be pulled into place after Subject's exit into the  
utility area.

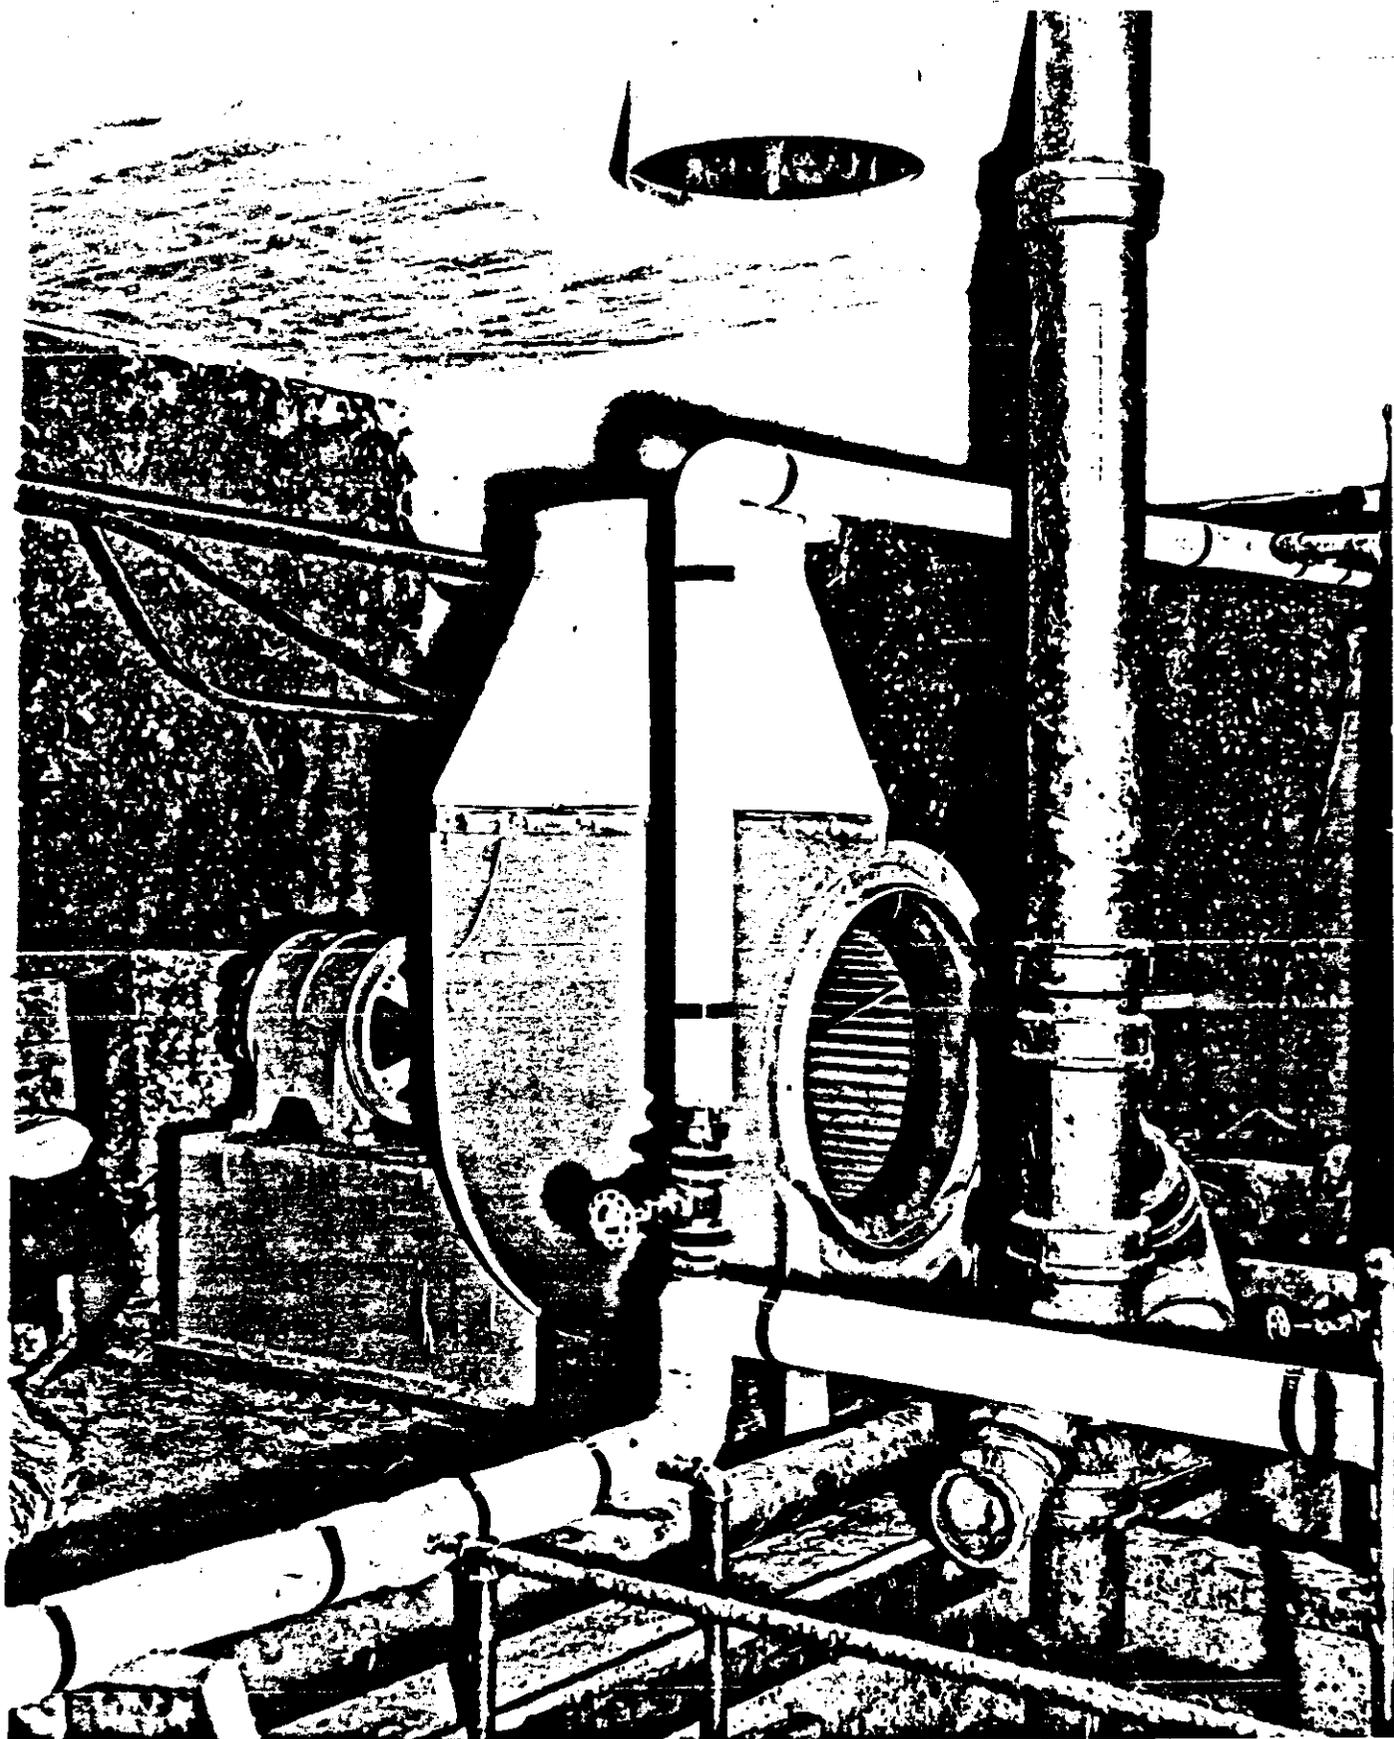
3-10 Photograph taken of the abandoned ventilating fan with opening through to the roof. Left rear and center background shows the manner in which this area was completely enclosed by drop cloths and blankets hung ostensibly to prevent splattering of paint into the cell block.

It was in this ventilator that the abandoned pantoon and two bundles of raincoats were located. Articles at the bottom of this ventilator could be reached by a long poke which had a nail protruding and could be used as a hook.

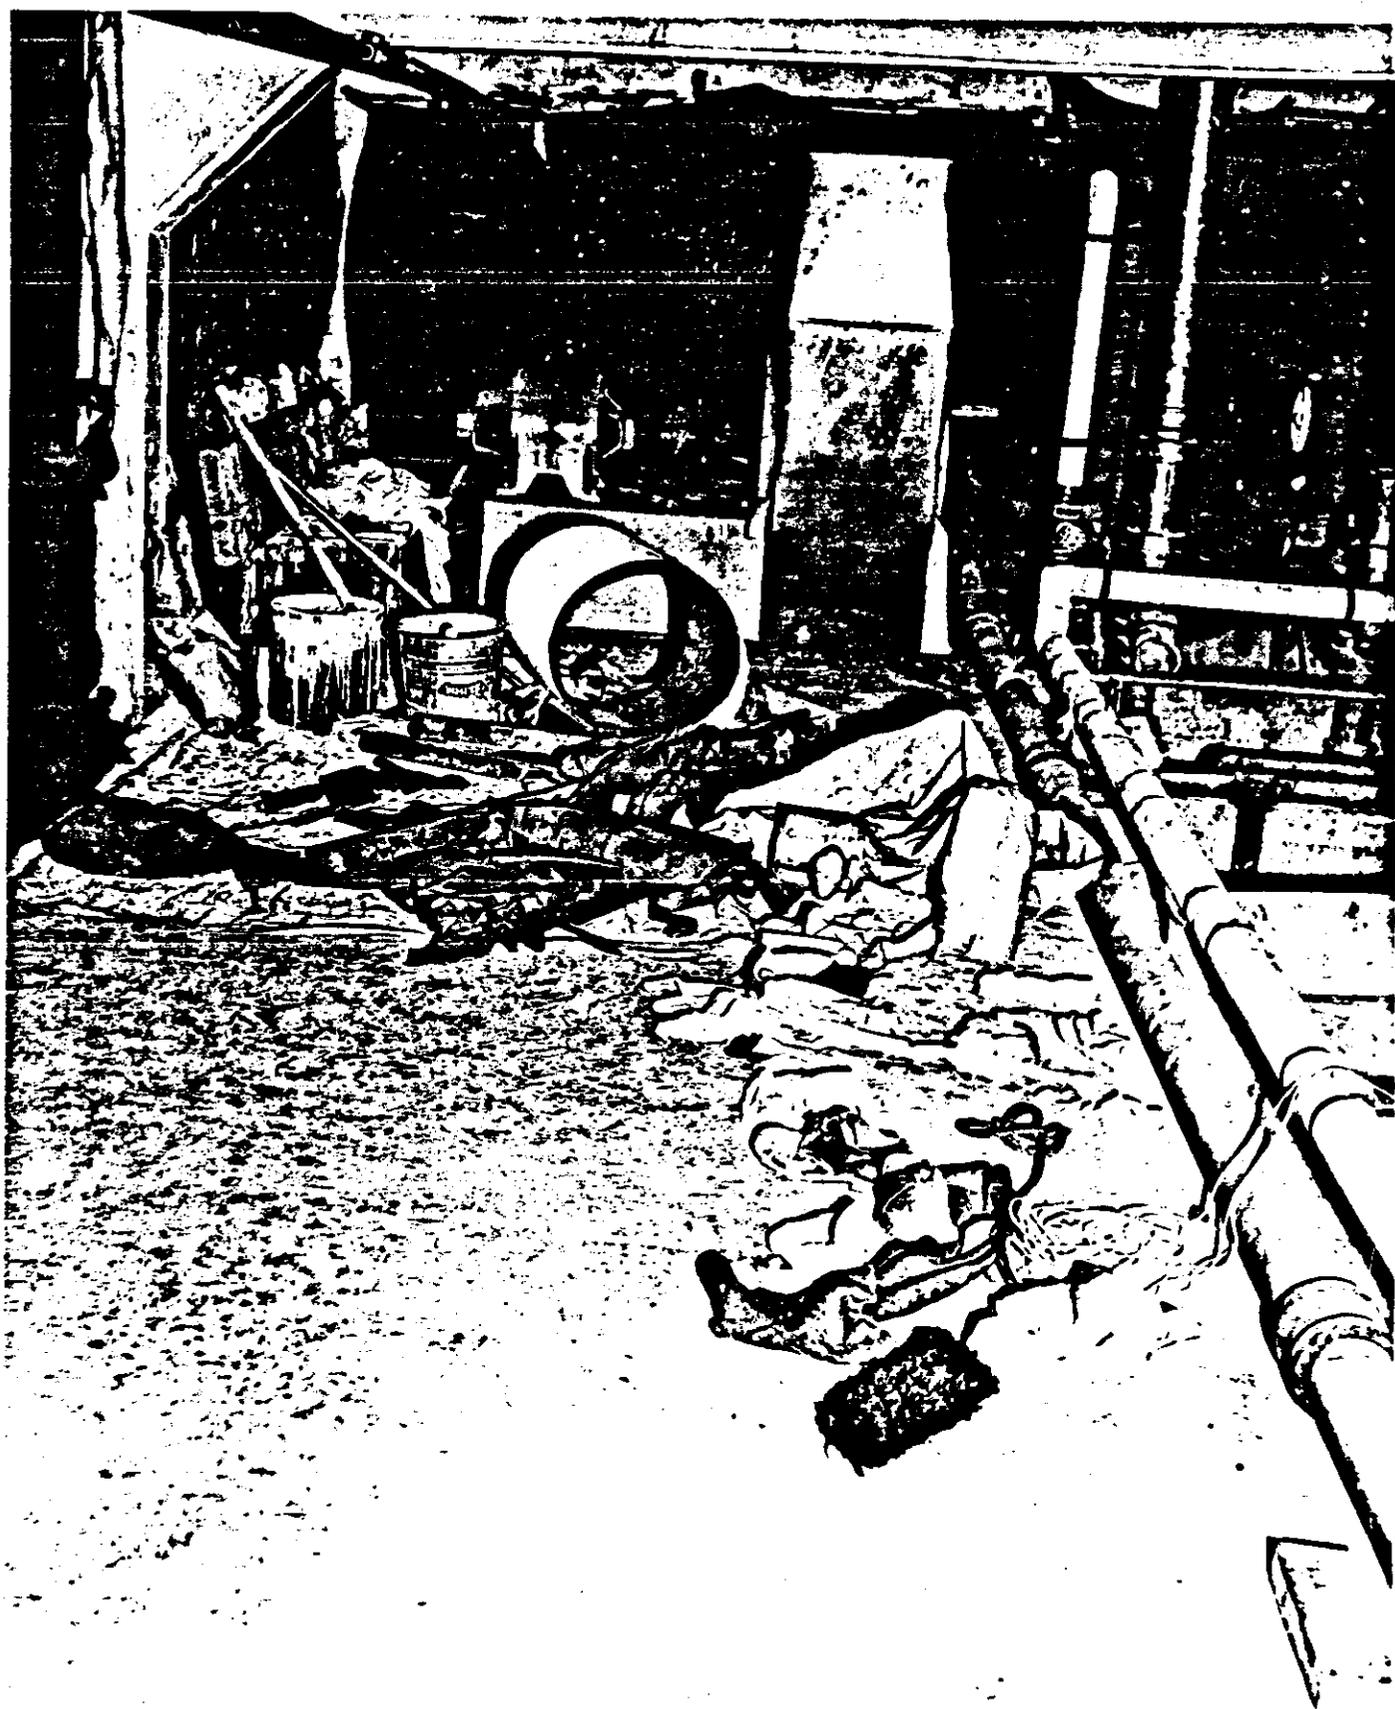
3-11 A general view looking toward the end of Cell Block B. The portion of the blanketed grill wall seen across the upper portion of the picture was across the end of the cell block. Approximately directly opposite the large black cast iron vent seen in upper right and down on the main floor was the main entrance to the entire cell area. The blanketed or screened-in area covered an area approximately thirty to thirty-five feet in length from the end of the cell block and extending on both sides, giving perfect concealment.

At lower right center may be seen a white cord which was tied to the hot water pipe crossing between Cell Block B and C and was one inch in diameter. This cord was lowered down the utility shaft and upon reaching the bottom, which was directly behind Subject's cells, it was determined to be twenty-six feet ten inches. Sections of this cord were knotted at intervals which apparently indicated the tier level reached when lowering or raising the rope. Fragments of raincoat material may be observed in general debris in center of picture. The five-gallon paint bucket from which a stick is seen protruding contained hardened cement paint and it was in this bucket a number of the Subjects' tools were subsequently located.

The heavy plank extending across the chair may have been used as the weight necessary when "vulcanizing" the seams on the raft and "Mae West" jacket.

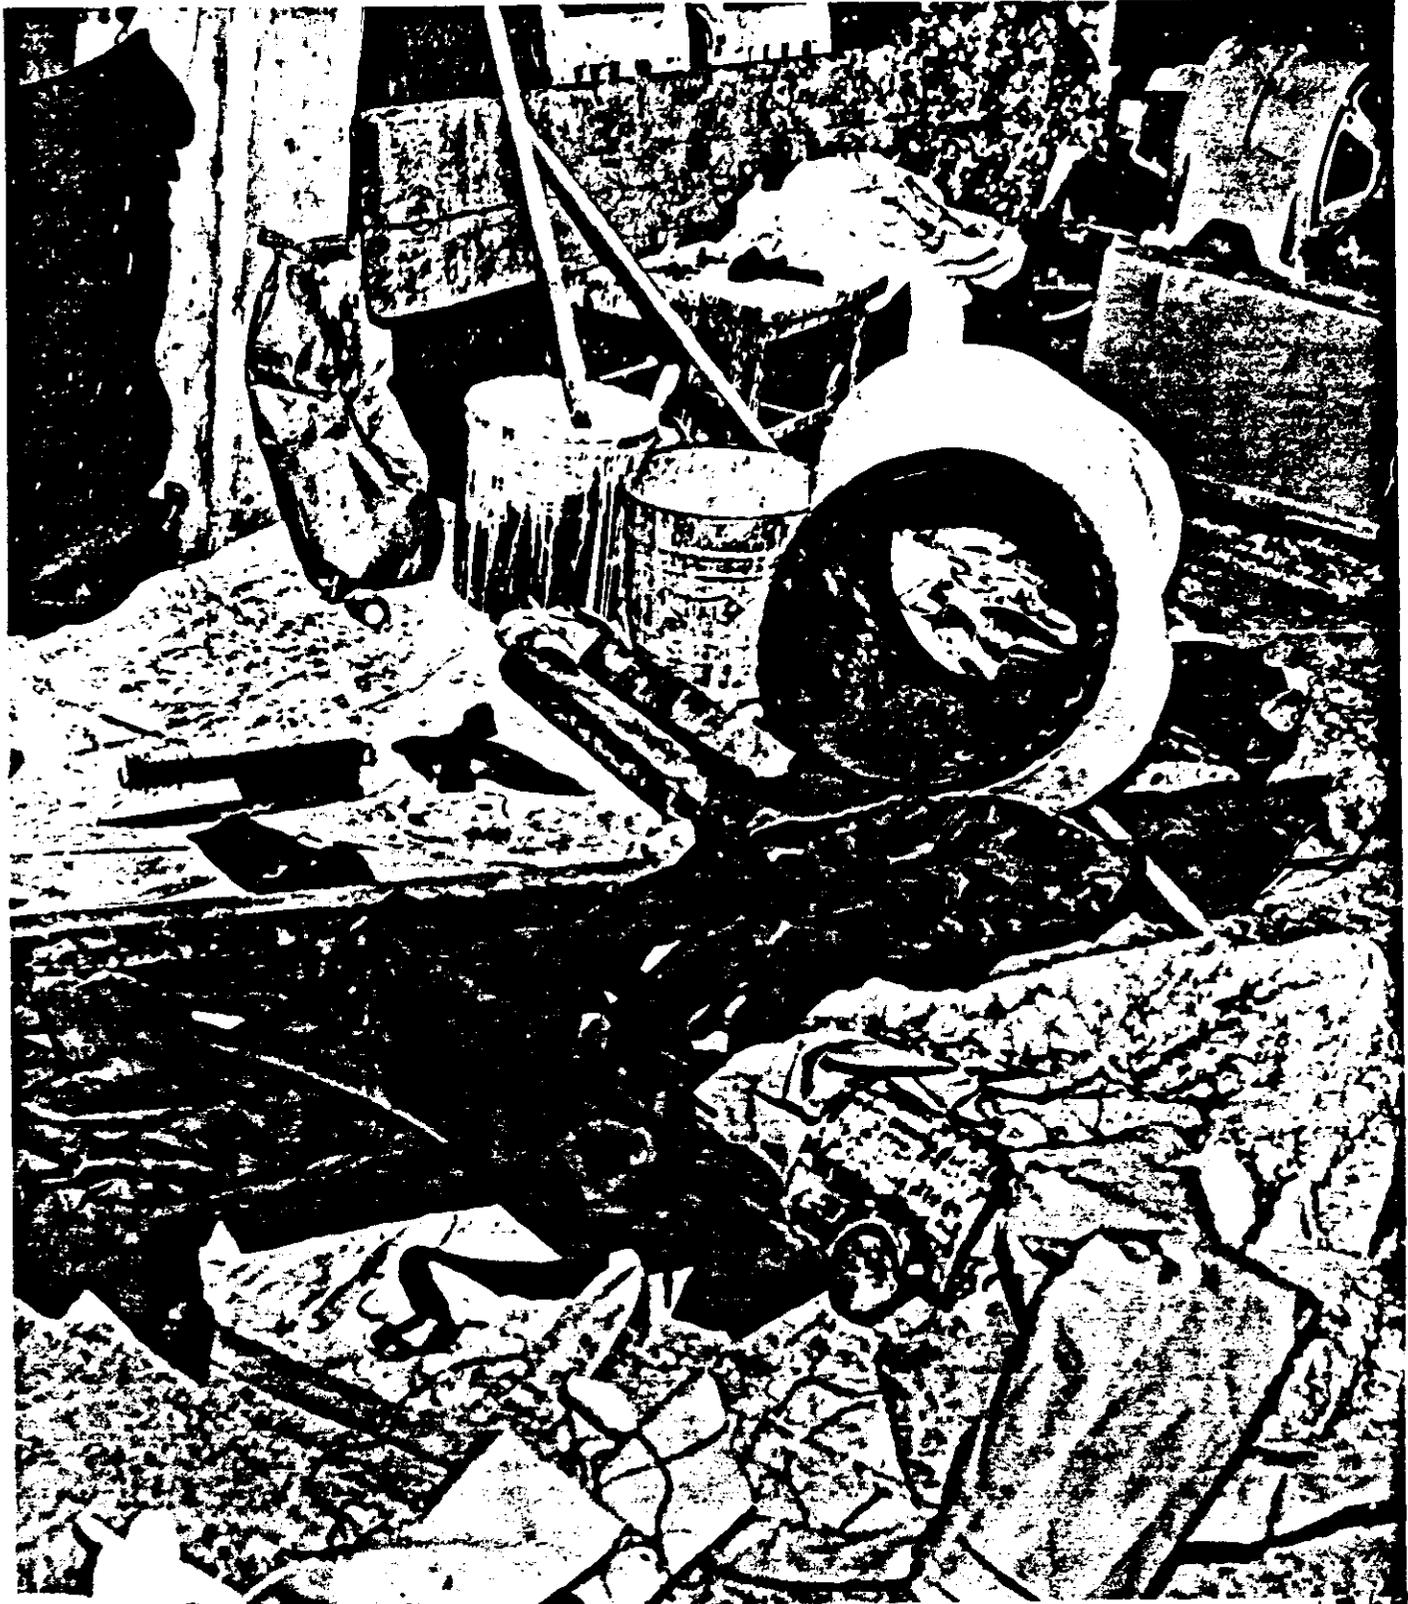
3-12 General view taken approximately fifteen feet from the bucket seen in center foreground. Lower left center are pieces of white Navy blanket cut in strips. The material seen at lower right is a type believed to have been used in making the raft. The goosenecked connector from the ventilating motor to the roof is seen in upper right. On the chair may be seen the remains of some brass bolts which were either machine or electrical bolts and brass washers and nuts identical to those found in the paddle.
