SUBJECT John Anglin, Clarence Anglin and  
Frank Lee Morris Escape from Alcatraz

FILE NUMBER 76-26295

VOLUME NUMBER Enclosures 76, 137, 155 and 179

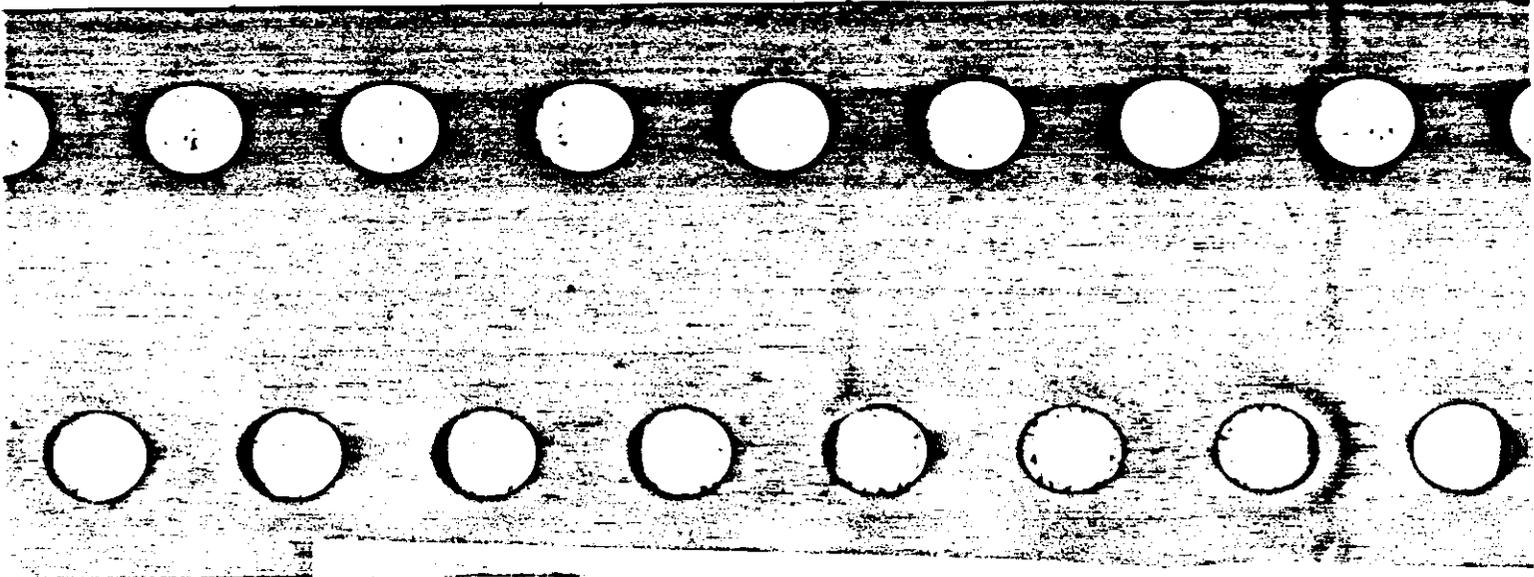
Side view of concrete replica.

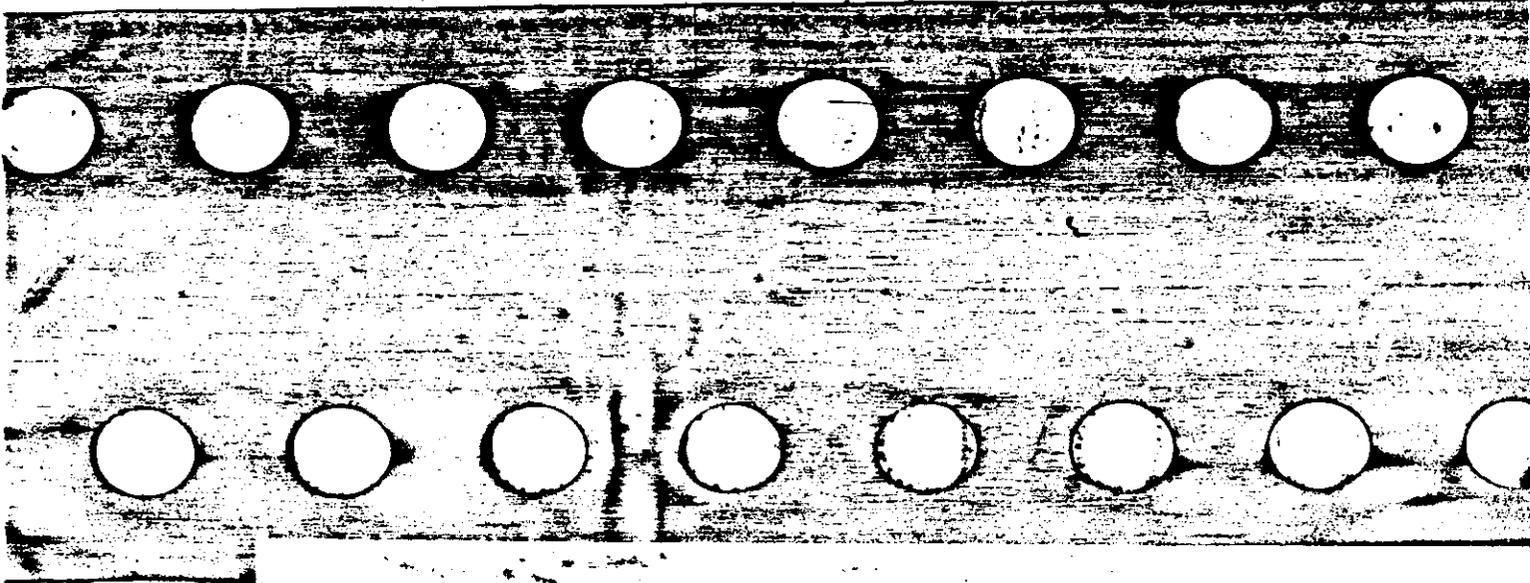
Rear view of concrete replica showing hard board. Note the wire hooks which were used to draw the replica into place from the inside of the cell.
