SUBJECT THE HINDENBERG

REPORT MADE AT <b>WASHINGTON, D. C.</b>	DATE WHEN MADE <b>6/17/37</b>	PERIOD FOR WHICH MADE <b>6/12-16/37</b>	REPORT MADE BY <b>[Redacted]</b>
TITLE <b>DESTRUCTION OF AIRSHIP "HINDENBURG"</b>			CHARACTER OF CASE <b>GOVERNMENT RESERVATION MATTER</b>

In an order dated May 7, 1937, made by the Secretary of Commerce pursuant to the Air Commerce Act of 1926, as amended, relating to the investigation of accidents in civil air navigation in the United States, South Trimble, Jr., solicitor, Maj. R. W. Schroeder, Assistant Director of the Bureau of Air Commerce, and Denis Mulligan, chief, Regulation and Enforcement Division of the Bureau of Air Commerce, all of the Department of Commerce, were designated to investigate the facts, conditions and circumstances of the accident involving the airship *Hindenburg*, which occurred on May 6, 1937, at the naval air station, Lakehurst, N. J., and to make a report thereon.

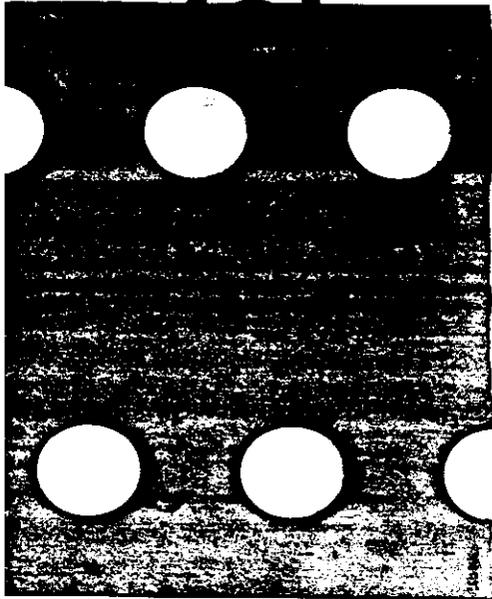
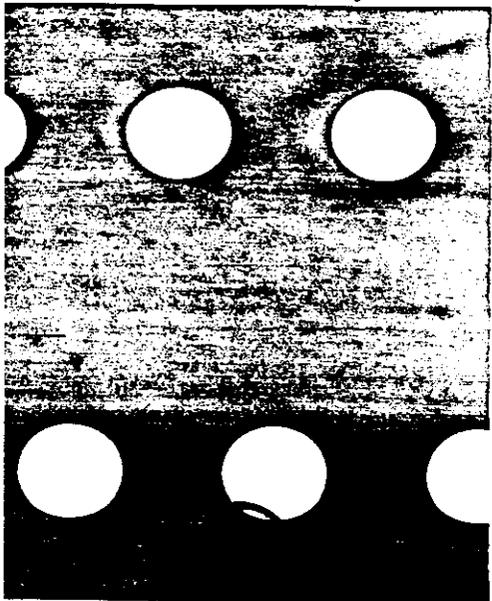
MICRO-BAROGRAPH (224-B)

STATION \_\_\_\_\_ DATE MAY 6, 1937 - MAY 7, 1937  
REMARKS \_\_\_\_\_

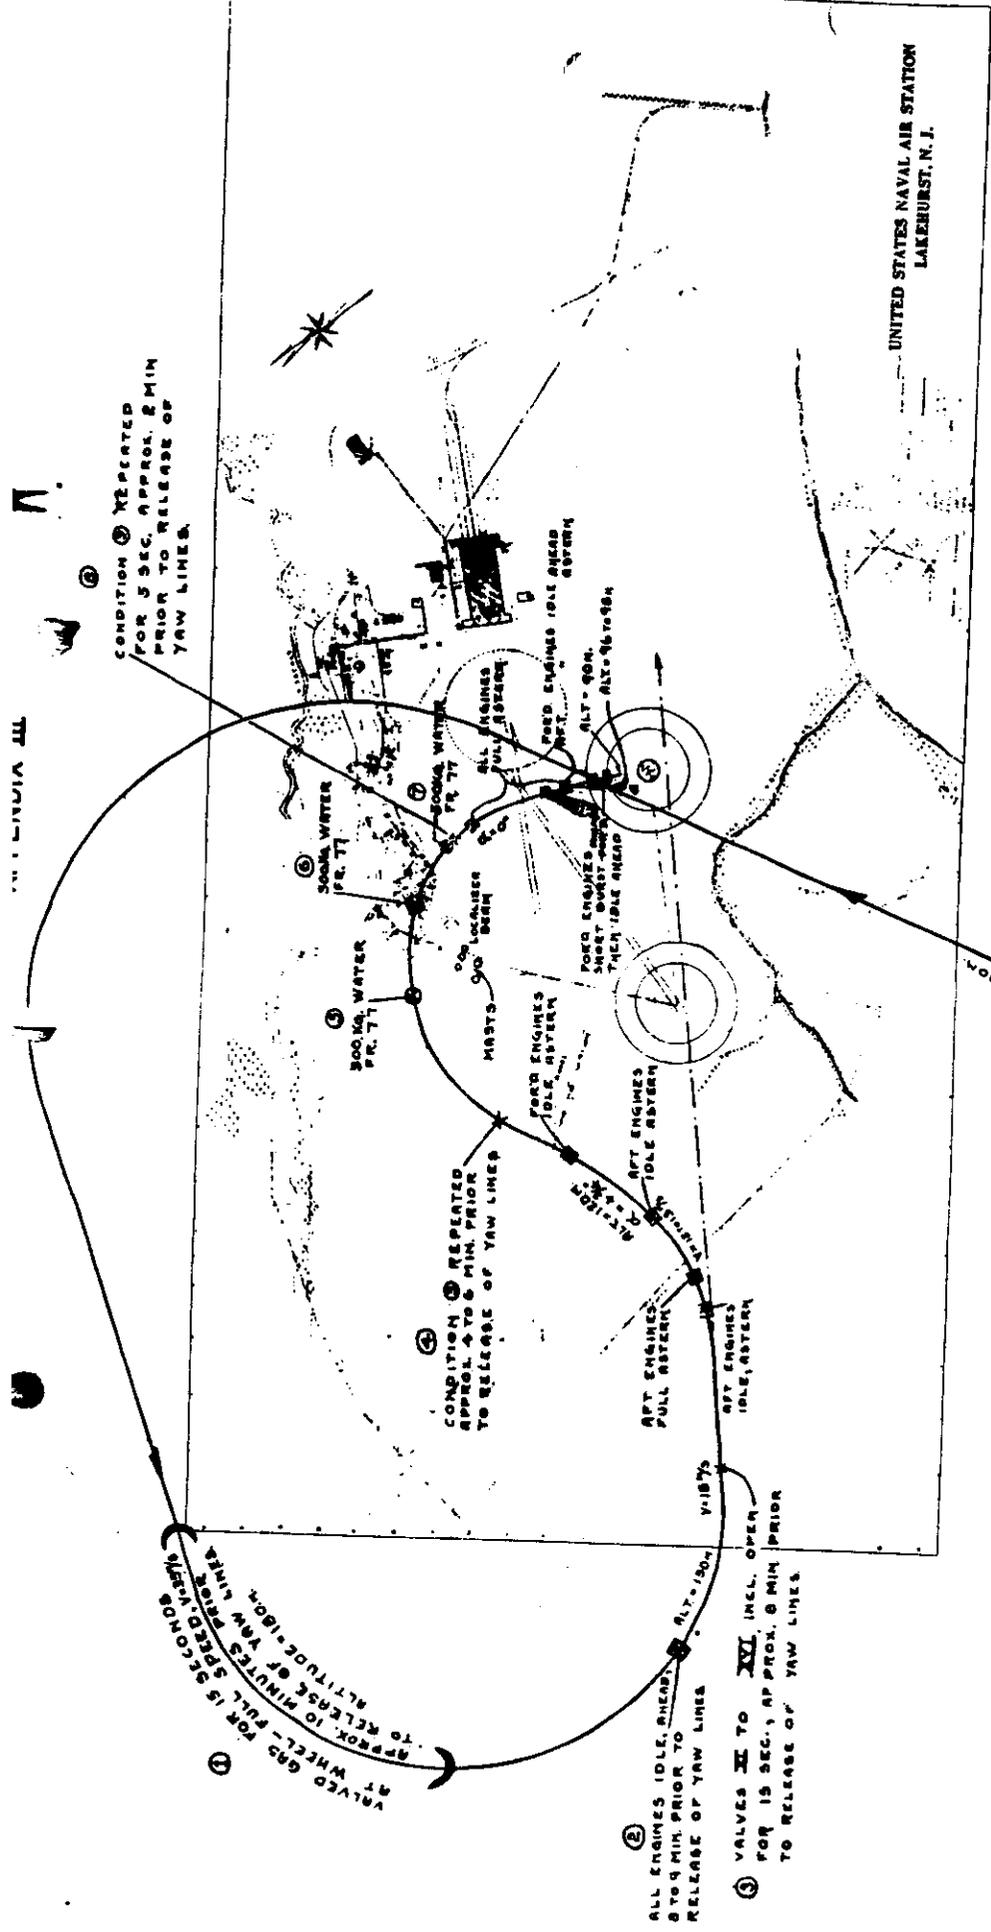
UNITED STATES NAVAL AIR STATION  
LAKEHURST, N. J.

④ CONDITION ② REPEATED APPROX. 4 TO 6 MIN. PRIOR TO RELEASE OF YAW LINES

⑤ CONDITION ② REPEATED FOR 3 SEC. APPROX. 2 MIN PRIOR TO RELEASE OF YAW LINES
